2016
Commonwealth of the Northern Mariana Islands
303(d), 305(b) and 314
Water Quality Assessment Integrated Report

Bureau of Environmental and Coastal Quality
December 2016

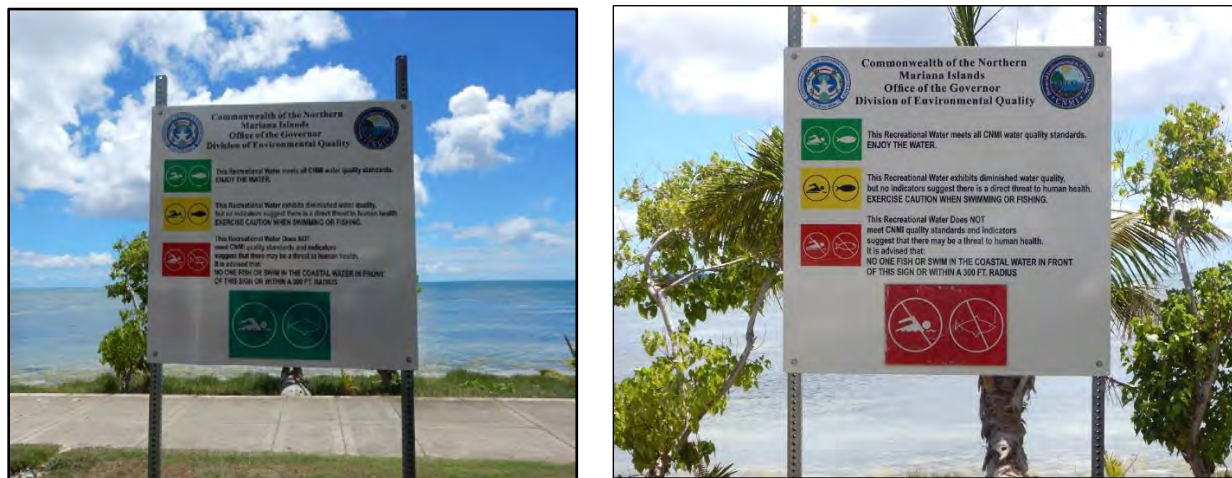
Figure C-37 Public Beach Advisory Sign Boards

Due to the frequency with which some beaches exceed the *Recreational Use* criteria, an elevated risk to public health exists for several beaches within the CNMI, and many of BECQ's programs are aimed at reducing this risk. Along Saipan's western shoreline most of the Enterococci contamination in densely populated areas are suspected to be indicative of contamination with human waste. Known sources of the bacterial contamination are overflows and leaks from sewage collection systems, and runoff from densely populated areas. Sample sites are commonly
