2018  
Commonwealth of the Northern Mariana Islands  
305(b) and 303(d),  
Water Quality Assessment Integrated Report

Bureau of Environmental and Coastal Quality  
September 2018

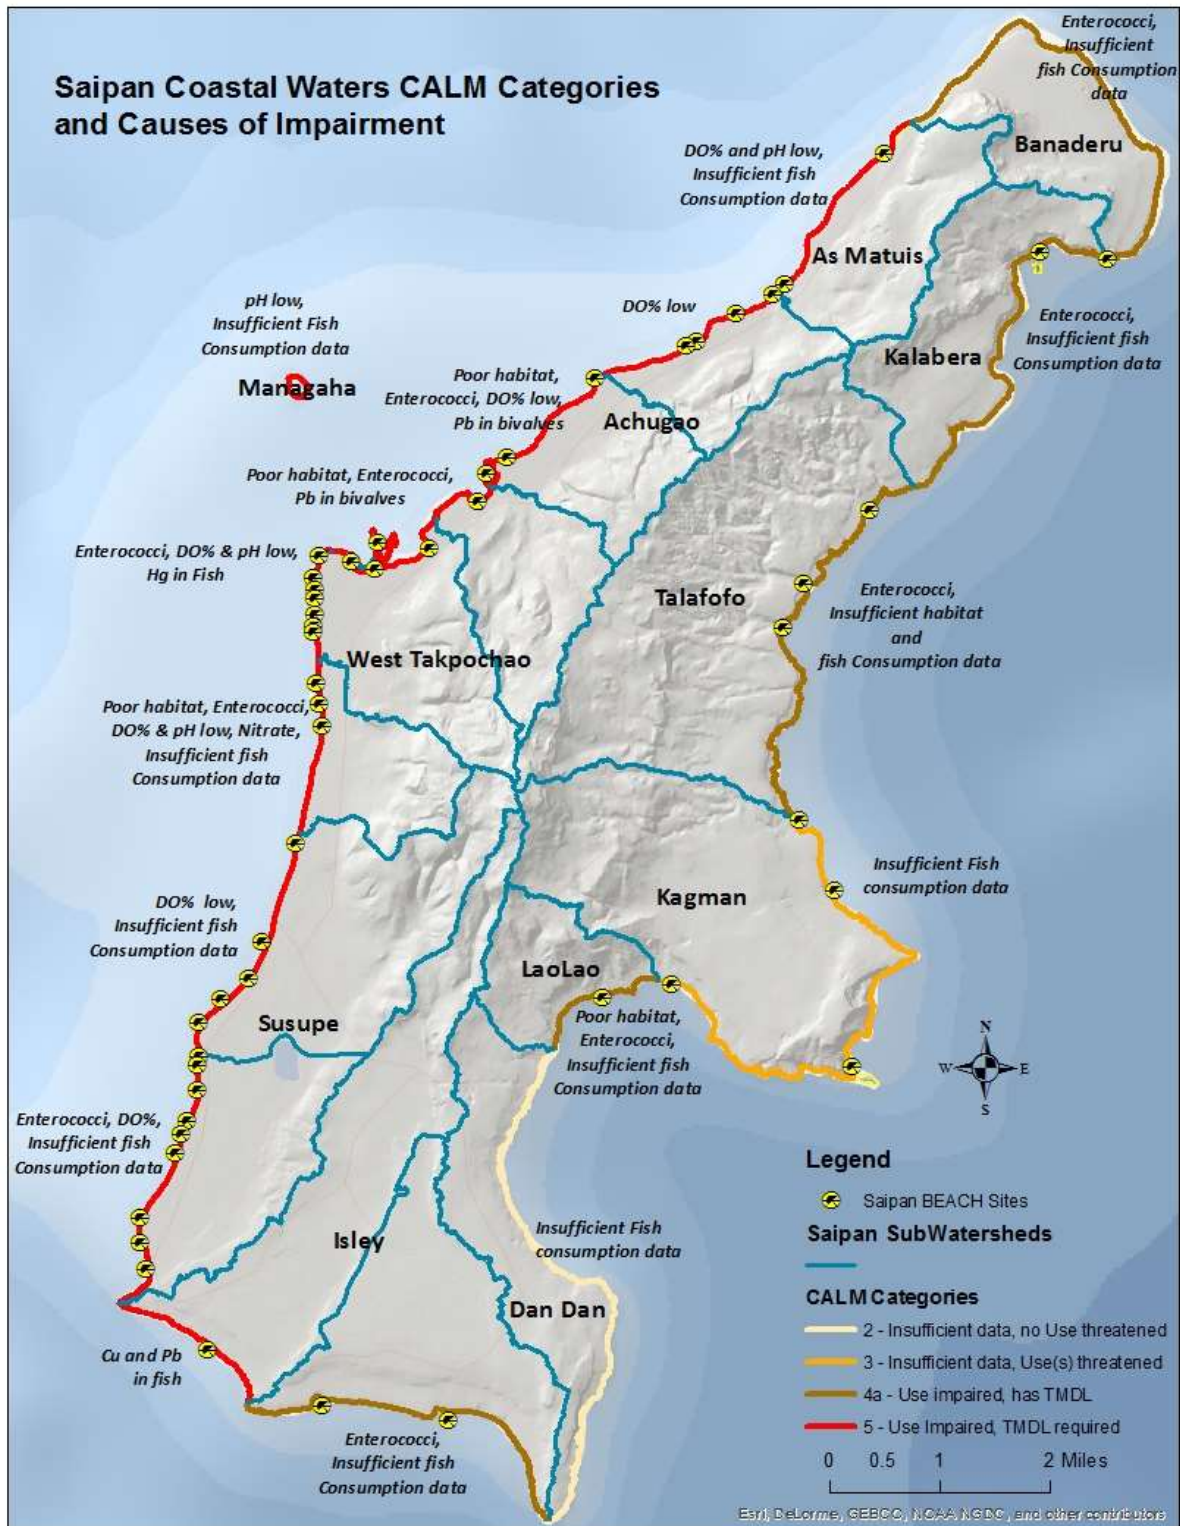
FIGURE I. Saipan Coastal CALM Categories and Causes of Impairment

Figures I – III., on the following pages depict the various causes of coastal water impairment, as well as the watershed’s Consolidated Assessment and Listing Methodology (CALM) category.

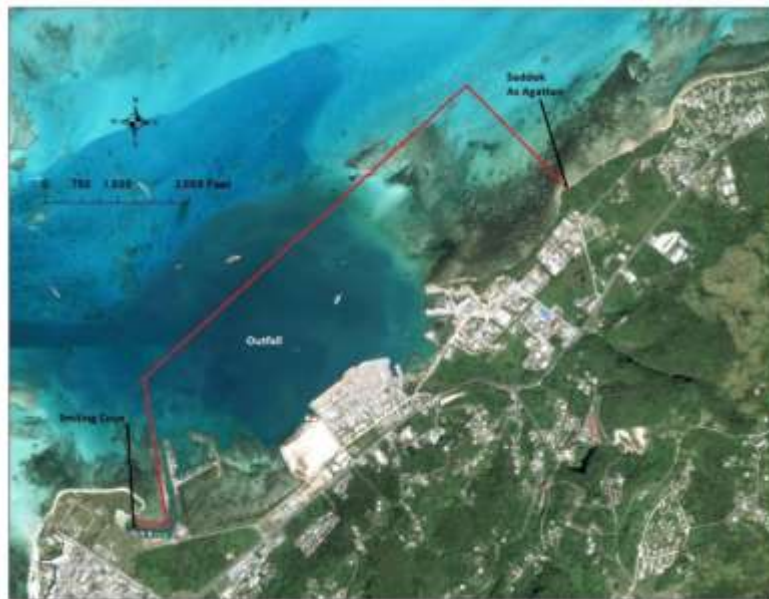
**FIGURE B-2. Class A Waters within 3000 ft of Puerto Rico Industrial Area, Saipan**

Class A waters are protected for their *Recreational* and *Aesthetic Enjoyment* DUs. The WQS allows for other uses as long as those uses support the *protection and propagation of fish and shellfish*, and wildlife, and *recreation in and on the water with limited body contact*. In other words, the DUs recommended in the CWA.

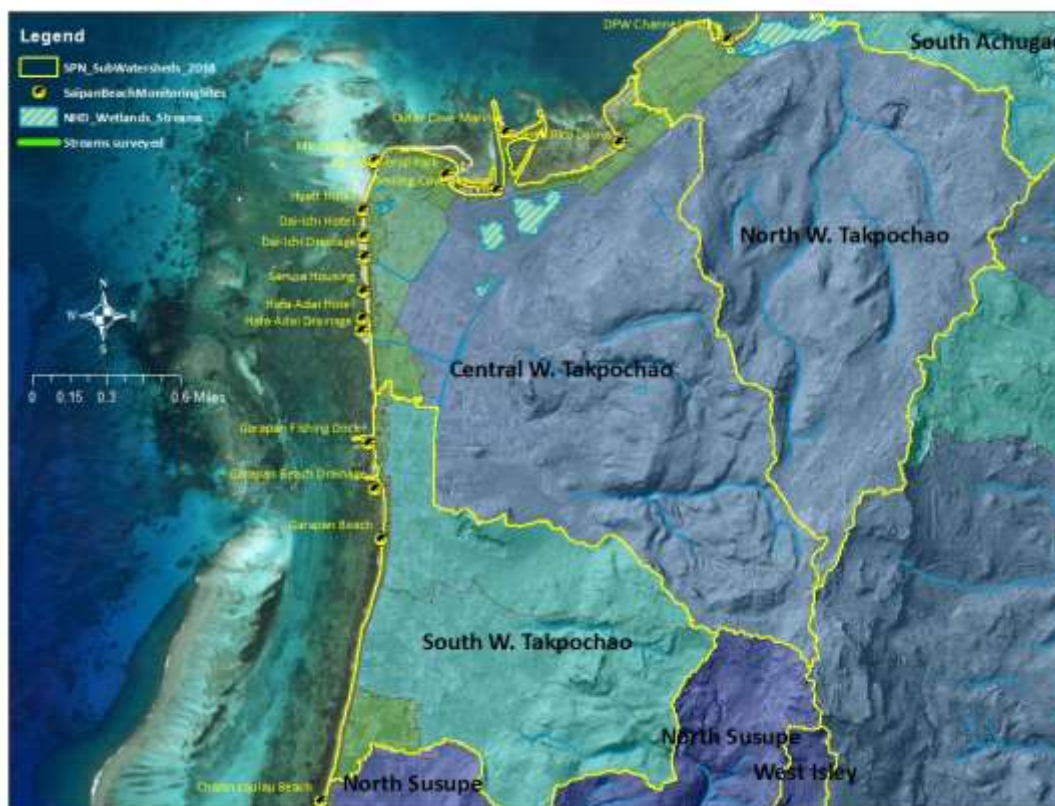
**FIGURE C-20. New Sub-watershed Boundaries using 2017 Watershed Catchment Basins**

The new sub-watershed boundaries are display in Figure C-20., below and are depicted in various shades of green to purple based on size of land area.
