Commonwealth of the Northern Mariana Islands Integrated 305(b) and 303(d) Water Quality Assessment Report

Division of Environmental Quality
May, 2004

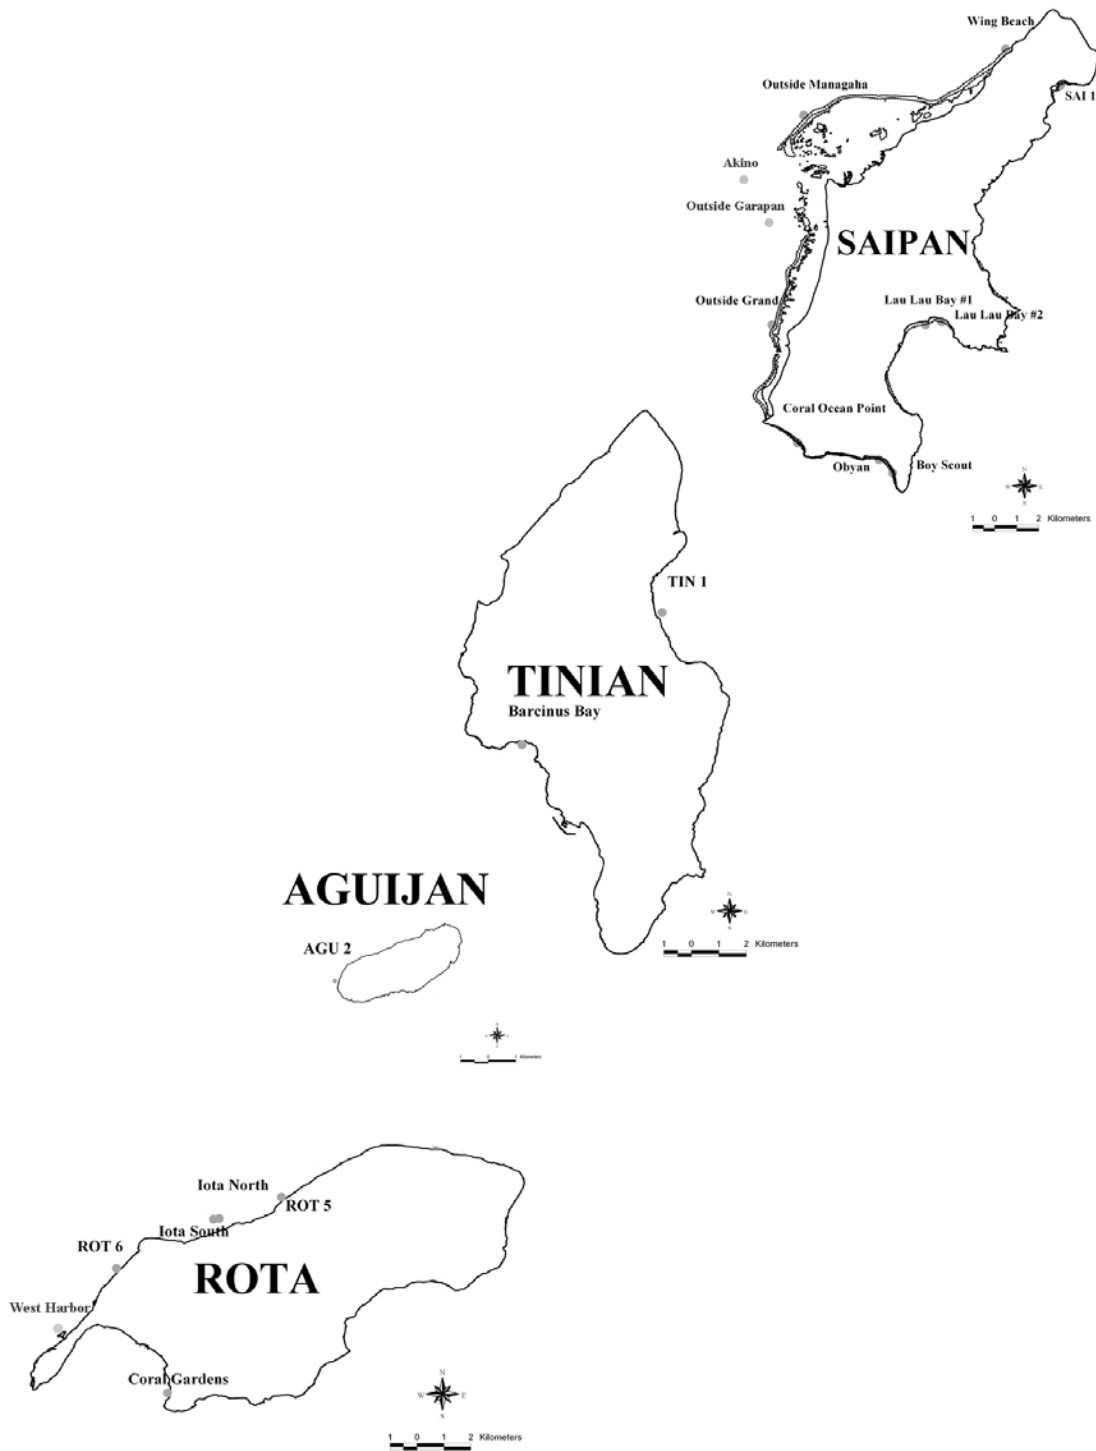
Figure 10. A map of coral reef biocriteria monitoring locations used in the present assessment.

Twenty coral reef monitoring locations were used for waterbody evaluation (Figure 10). While the CNMI reef monitoring program has a better spatial coverage than shown, only sites with appropriate reef development can be used to evaluate water quality. At other locations, environmental factors such as exposure, reef slope, and prior geological development have a larger influence on the benthic community than water quality, and benthic data are not appropriate for evaluation of water quality.
