2022
Commonwealth of the Northern Mariana Islands
305(b) and 303(d)
Water Quality Assessment Integrated Report

Bureau of Environmental and Coastal Quality
OCTOBER 2022

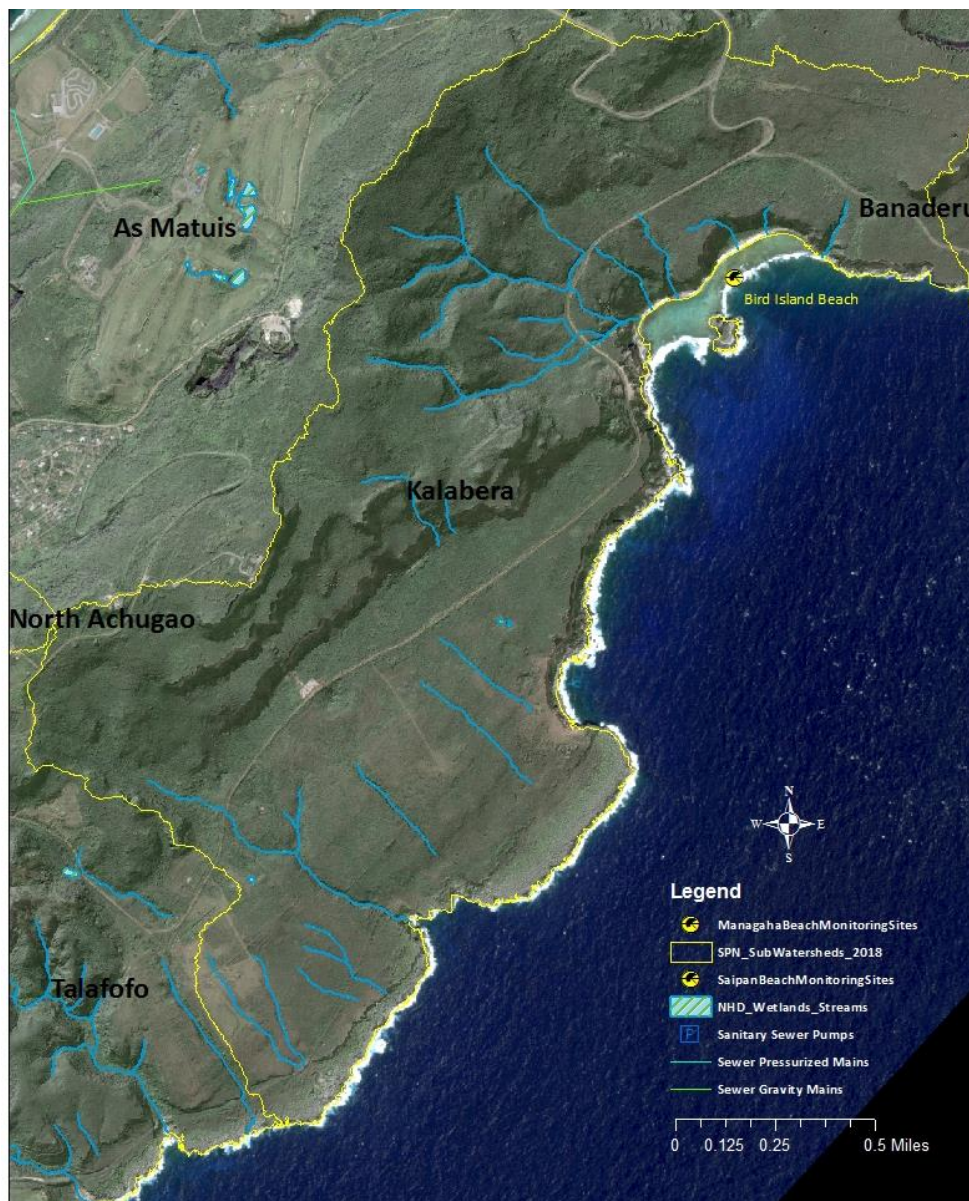
FIGURE C-9. Kalabera Watershed (Segment 12)

Kalabera Watershed is the northernmost watershed on Saipan’s east coast. It is rural in nature, with few roads or impervious land cover, as seen in Figure C-9. Kalabera has only one long-term BEACH monitoring site, which is located next to Bird Island Beach’s shoreline.

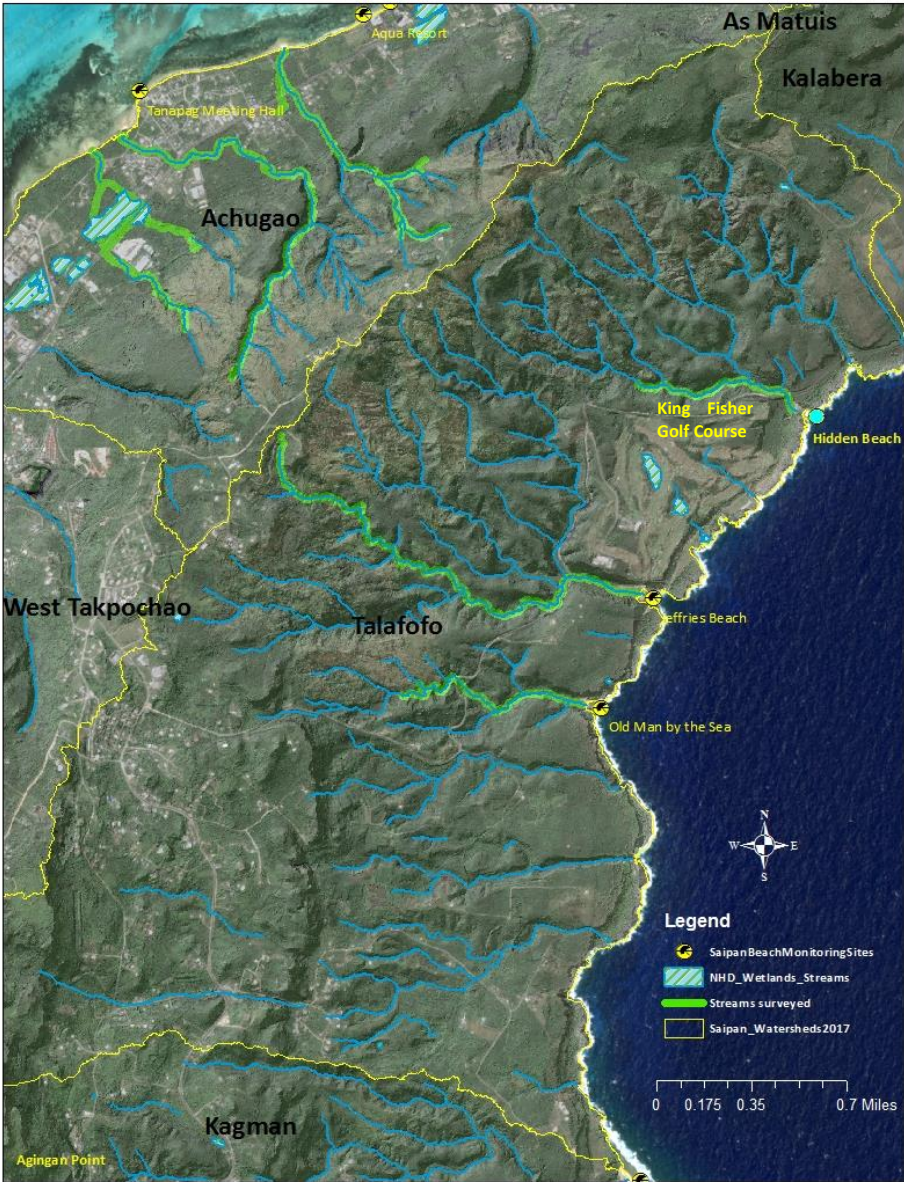
FIGURE C-10. Talofofo Watershed (Segment 13)

Talofofo Watershed’s long-term BEACH monitoring sites are located in the waters surrounding three remote beaches: Hidden, Jeffrey’s, and Old Man by the Sea, as shown in Figure C-10.

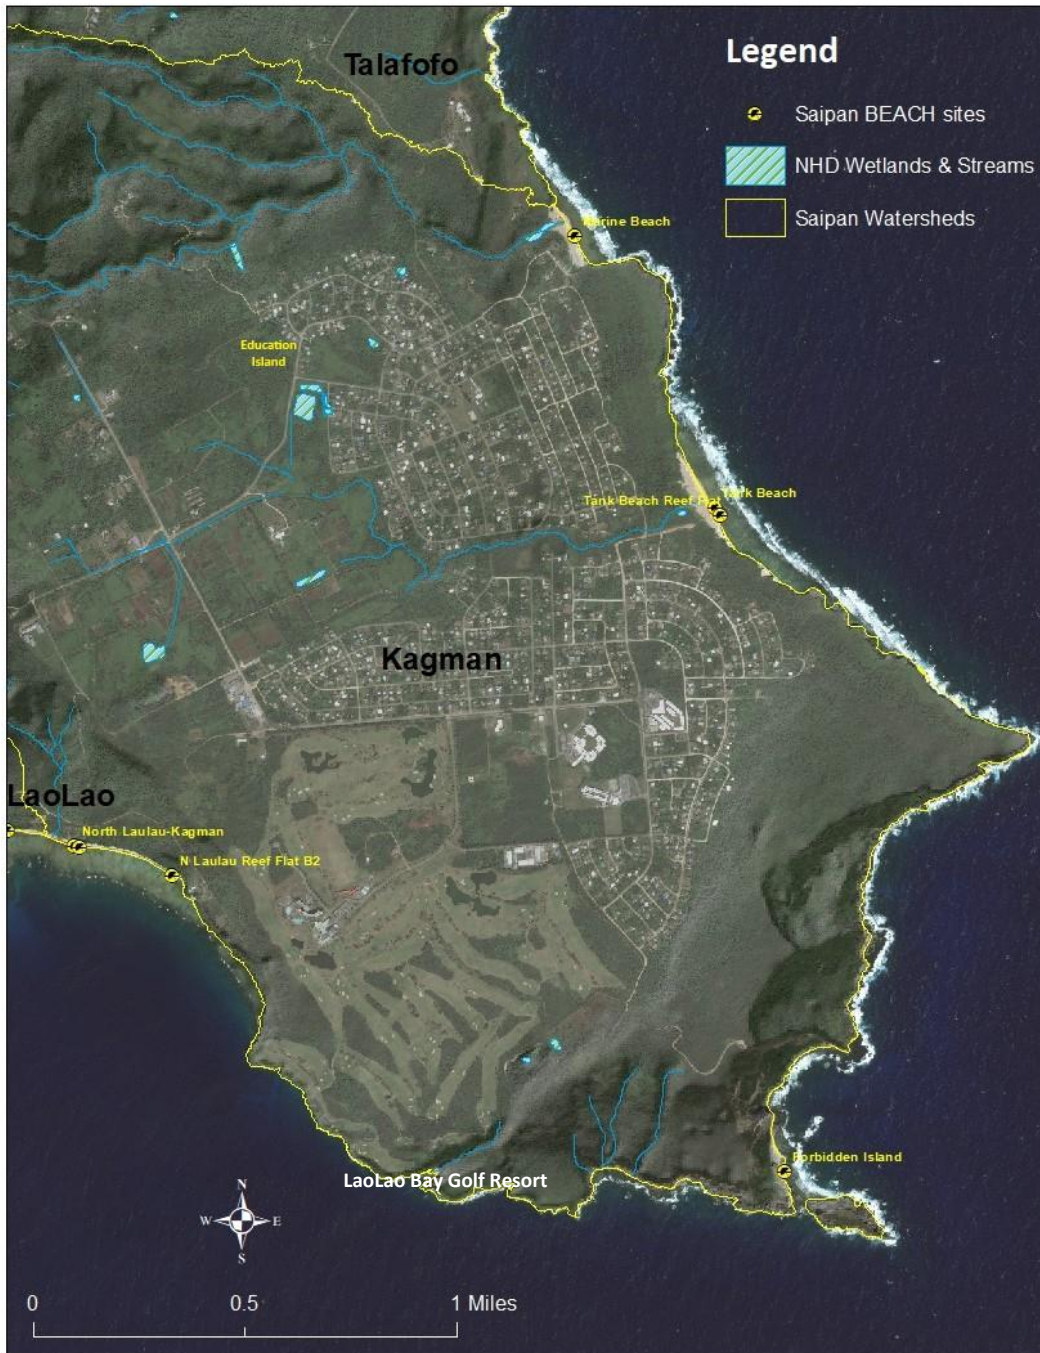
FIGURE C-11. Kagman Watershed (Segment 14)

The Kagman Watershed borders Laolao Bay and contains the Laolao Bay Golf Resort, shown in Figure C-11., on the following page.

It has four long-term BEACH monitoring sites located in the waters surrounding Marine, Tank, Forbidden Island, and North LaoLao beaches. In addition, there are also three LaoLao ARRA water

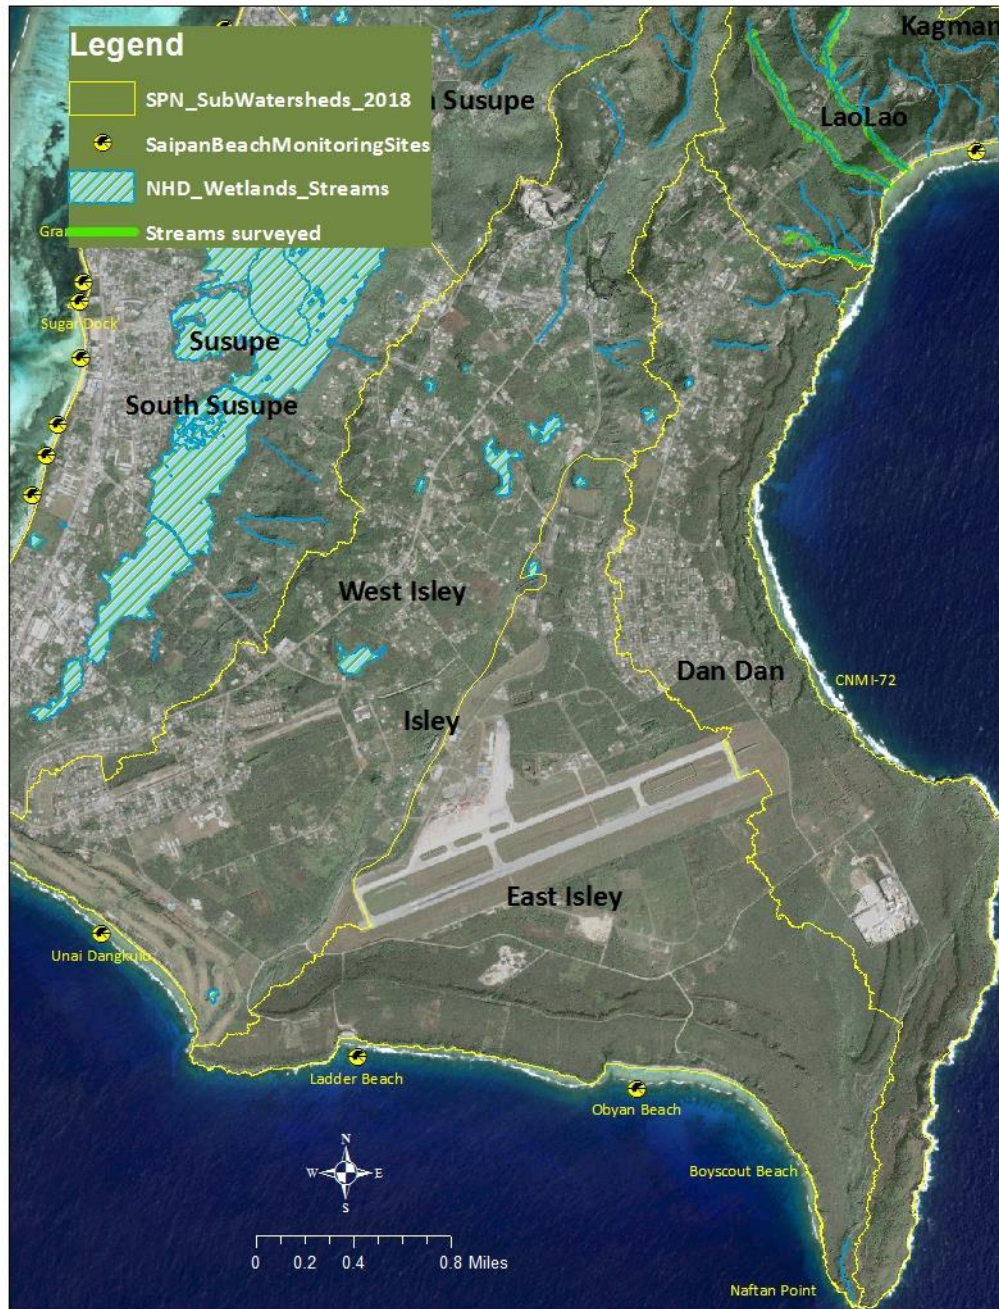
FIGURE C-16. Isley Watershed (Segment 17A and 17B)

The Isley Watershed (Figure C-16) is divided into sub-watersheds, East Isley (17B) and West (17A). Isley's headwaters start at the centrally located peak of Mt. Takpochau at 1554 feet. Mt. Takpochau's surface waters flow from its ridge by subterranean transport to the south coast.

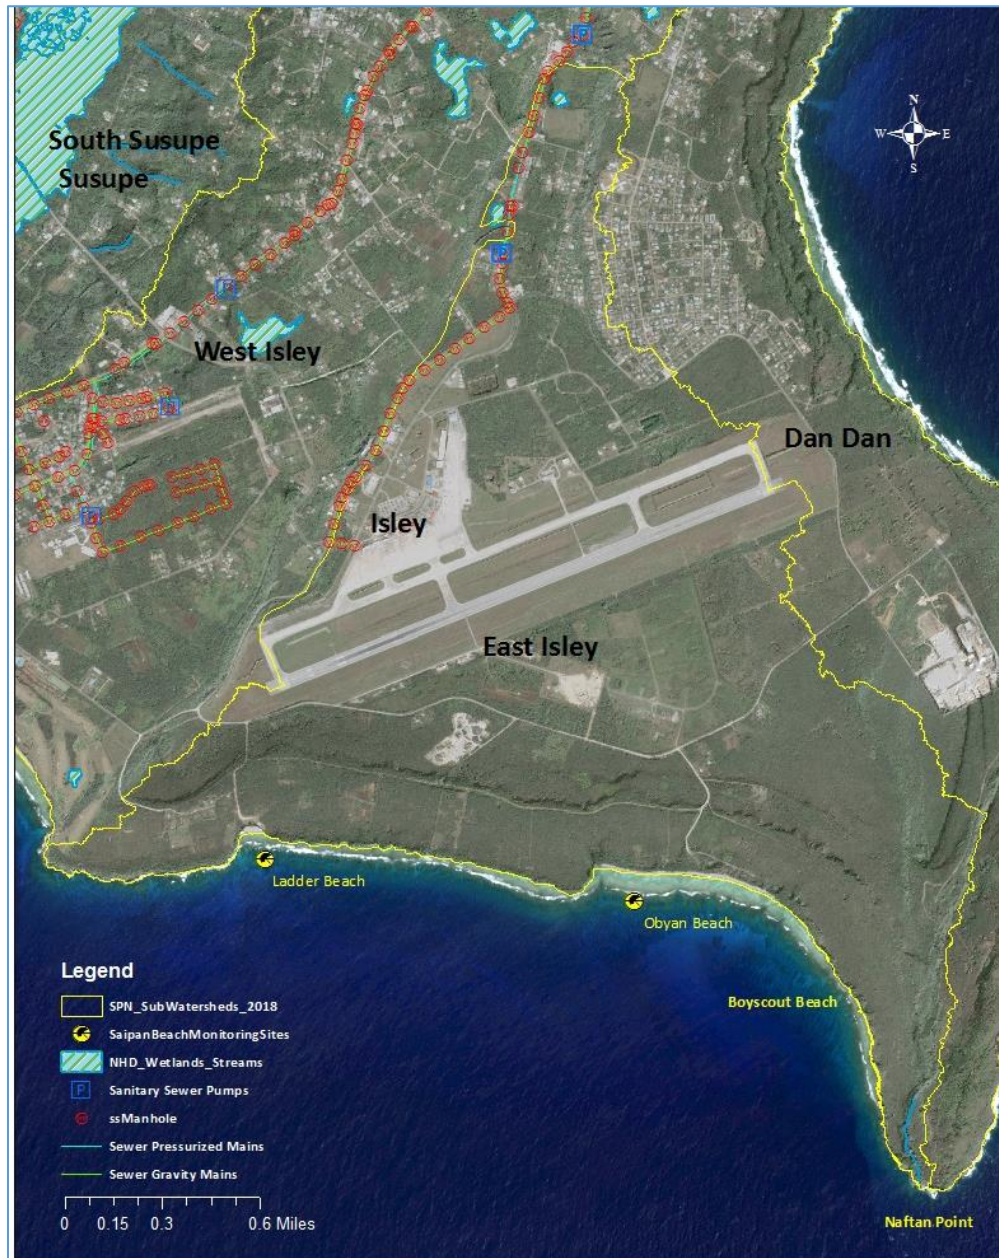
FIGURE C-17. East Isley Watershed (Segment 17B)

East Isley’s Watershed (Figure C-17.) contains Saipan’s present day, Francisco C. Ada International Airport that was constructed over a Formerly Used Defense Site (FUDS). A WWII military dumpsite is located in East Isley at Naftan Point. There is PFOS and FPOA contamination of ground water here associated with wartime activities, and airport firefighting drills.

The East Isley watershed is sparsely populated with a few homes compared to West Isley. There are two long-term BEACH monitoring sites located at Obyan and Ladder beaches, one reef flat site off Ladder Beach, and another biological monitoring site at Boy Scout Beach.

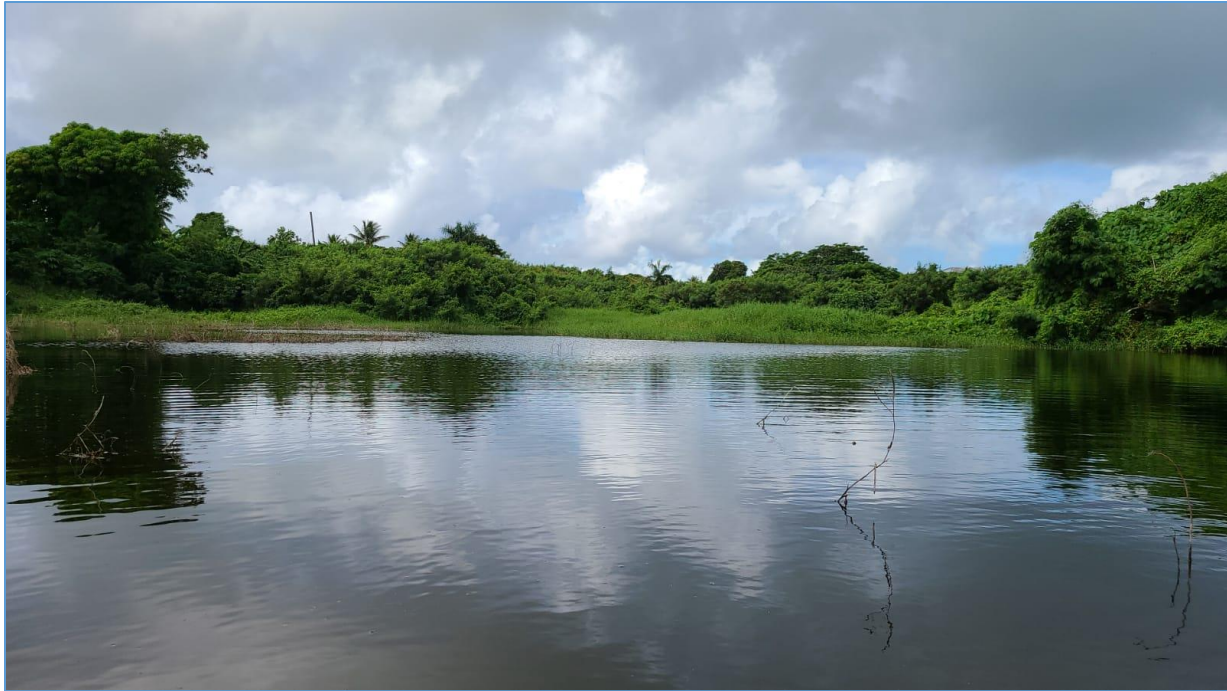
FIGURE C-21. Flores Pond in Rainy Season (NWCA – August 2021)

The most recent NHD, and Wetlands and Streams GIS data layers show significant natural emergent wetlands, or marsh areas that have been tilled for agriculture in the mid and upper West Isley watershed, as well as a constructed mitigation wetland, and the Flores Pond system (Figure C-21).

These wetlands exist due to clay geology which acts as an aquitard and holds the freshwater longer than in other places on Saipan. Information gathered during the 2021 NWCA found that Flores Pond does not contain standing water year-round that would support fish, but it is home to many aquatic invertebrates when flooded, e.g., water striders, aquatic beetles and other insects. The Pond is an important migratory bird habitat for the endangered Mariana Moorhen. Therefore, West Isley's wetlands support the *Propagation of Aquatic Life* DU, but they also have altered habitats.

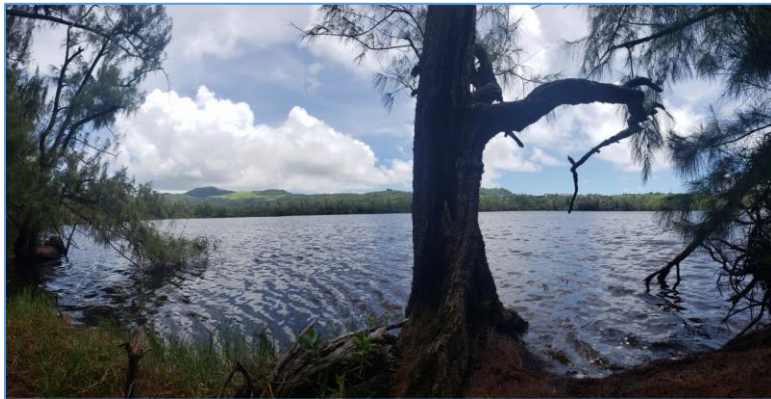
FIGURE C-26. Susupe Lake

The most recent study by Environet, Inc., entitled “*Assessment of Toxicity and Water Quality of Lake Susupe*”, concluded in 2006 that Susupe Lake, “consists primarily of rainfall with minimal groundwater influence” and is “isolated from surrounding groundwater and seawater systems”.

organochlorine pesticides, PCBs, volatile or semi-volatile compounds were detected.” The study went on to state that the Lake would require treatment to be used as a *Potable Water Supply* due to chloride (unpalatability) and *E. coli* levels.

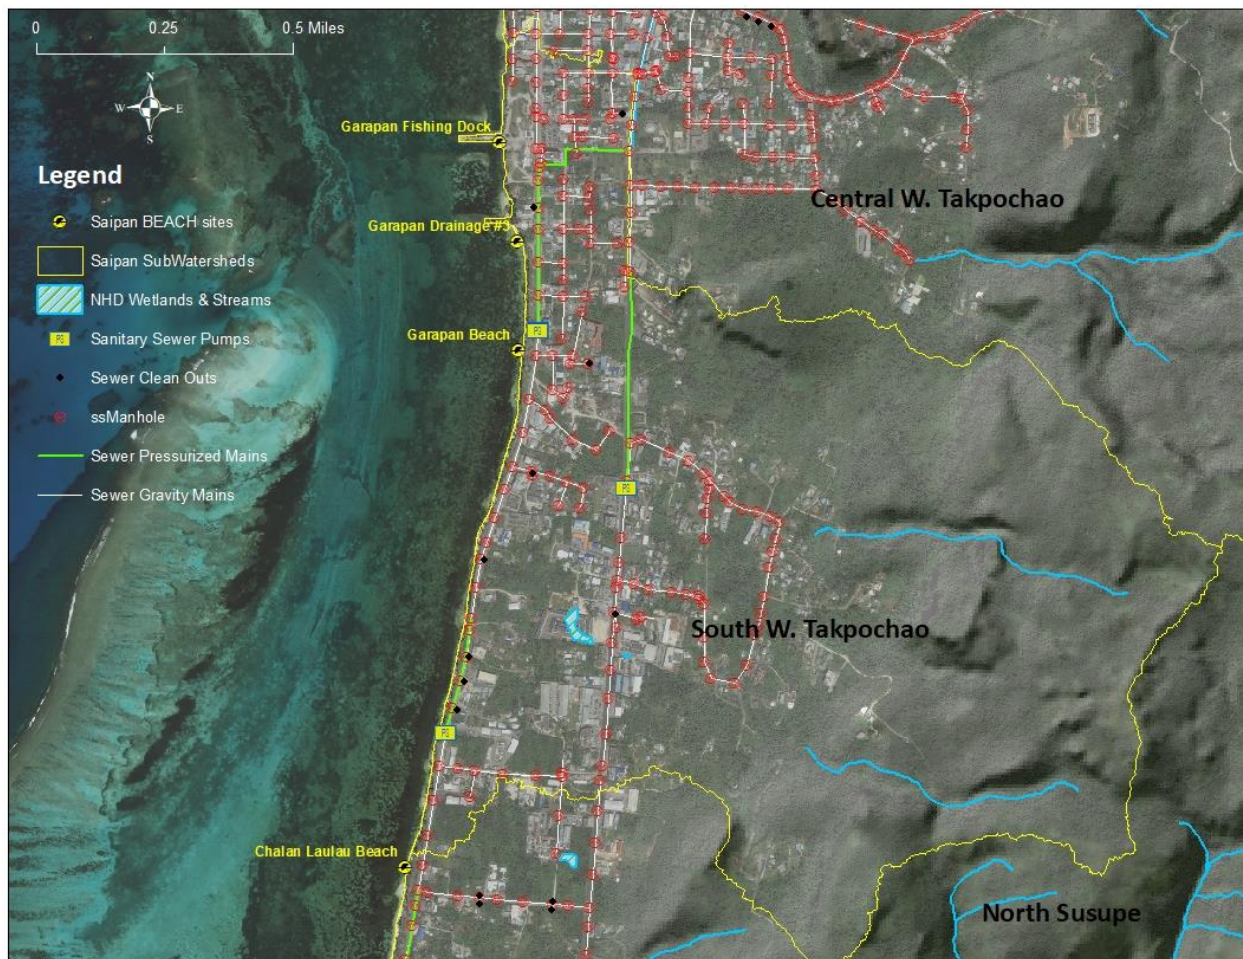
FIGURE C-30. South W. Takpochau Watershed (Segment 19C)

The South W. Takpochau contains three (3) long-term BEACH monitoring sites at Garapan Beach, north of the "13 Fishermen Monument", Garapan Drainage #3, and Garapan Fishing Dock. These are shown in Figure C-30.

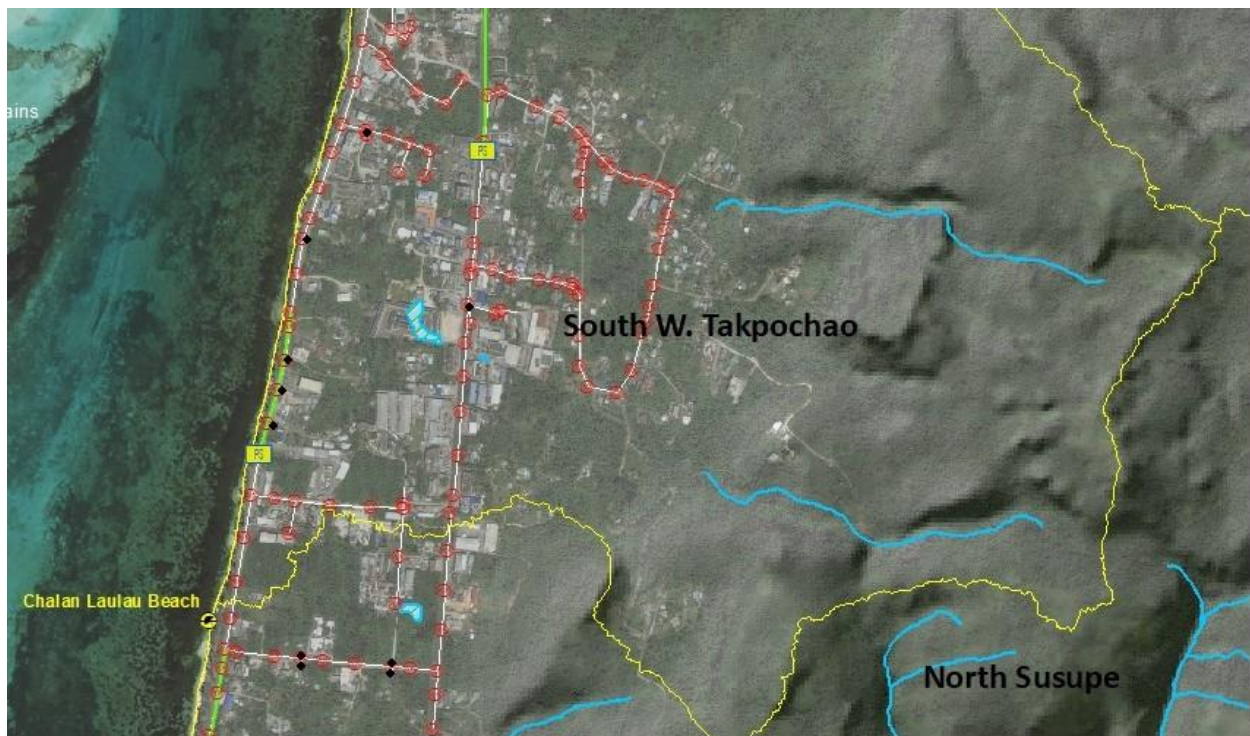
FIGURE C-31. South W. Takpochau Streams (Segment 19STRC)

There are two ephemeral streams in the South West Takpochau watershed as seen in the latest NHD, and Wetlands and Stream GIS data layers (Figure C-31). The streams' headwaters start at the ridge separating North Susupe from the South West Takpochau watershed. The streams flow on the surface from the steep upper watershed in the west, then subterranean through the lower watershed that discharges through groundwater seeps into Saipan Lagoon.

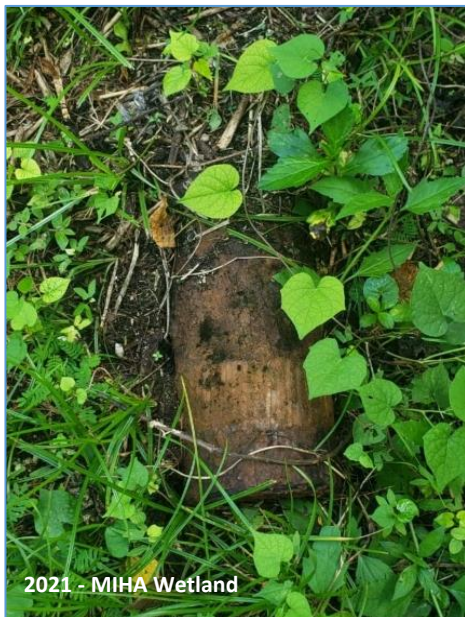
FIGURE C-34 UXO in MIHA Wetland

In FY2021 WQS/NPS staff began monitoring the wetland's water quality in preparation for a restoration project funded by National Fish and Wildlife Foundation. While water quality sampling, field staff discovered a UXO on the path leading into the wetland used by area residents. Its coordinates were taken and reported to SARS and DFEMS for removal.

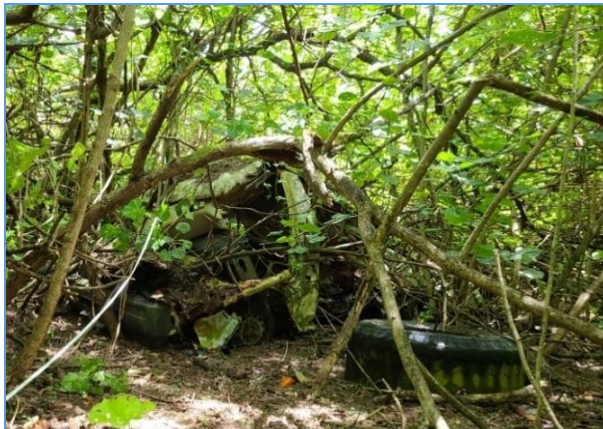
FIGURE C-36. 2021 NWCA Site Lower Base Wetland

WQS/NPS field crew visited several wetland sites in the North West Takpochau watershed during the 2021 NWCA. One lacustrine Hibiscus forested wetland located in Lower base southwest of JG Sablan repair shop had mounds of fill and WWII era debris at the wetland boundaries (Figure C-36).

The mounds of fill surrounding the wetland were used to redirect water flow and prevent flooding. Old tires, junk vehicles, trash, and a CUC water meter line and other infrastructure were observed within the wetland. Coral roadways surround the wetland, as do invasive vines.

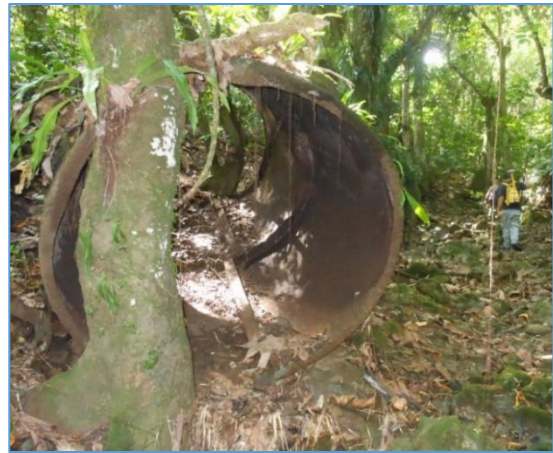
FIGURE C-40. Cistern in Dogas Streambed

SVAP assessments were completed within and around South Achugao’s As Agatan and Saddok Dogas stream systems. Several large cisterns from the Japanese occupation, metal drums, WWII UXO, planes and other military equipment can be found in the mid Saddok Dogas stream system.

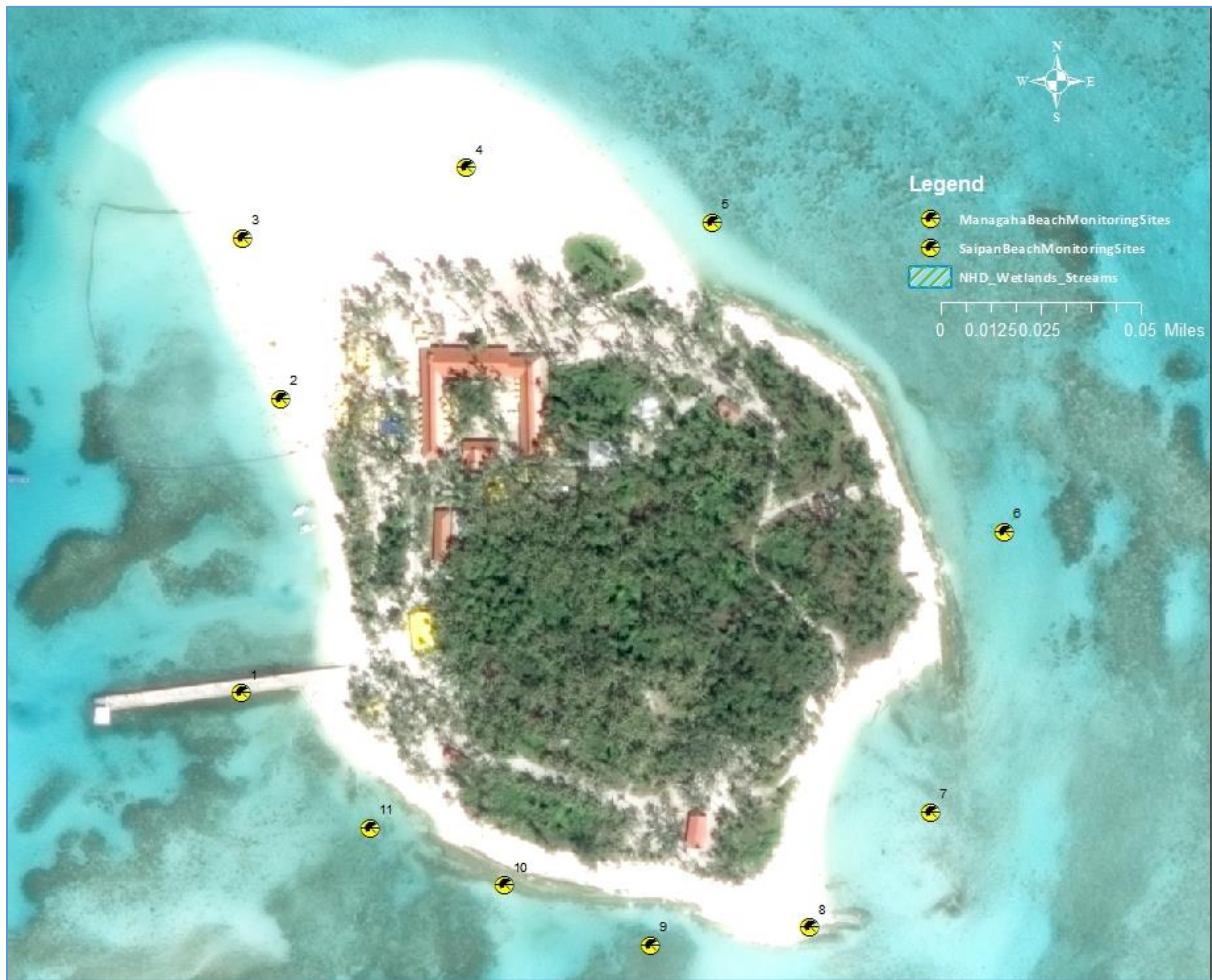
FIGURE C-51. Mañagaha (Segment 23)

There are 11 long-term BEACH monitoring sites surrounding Mañagaha’s shoreline and pier (Figure C-50., above).

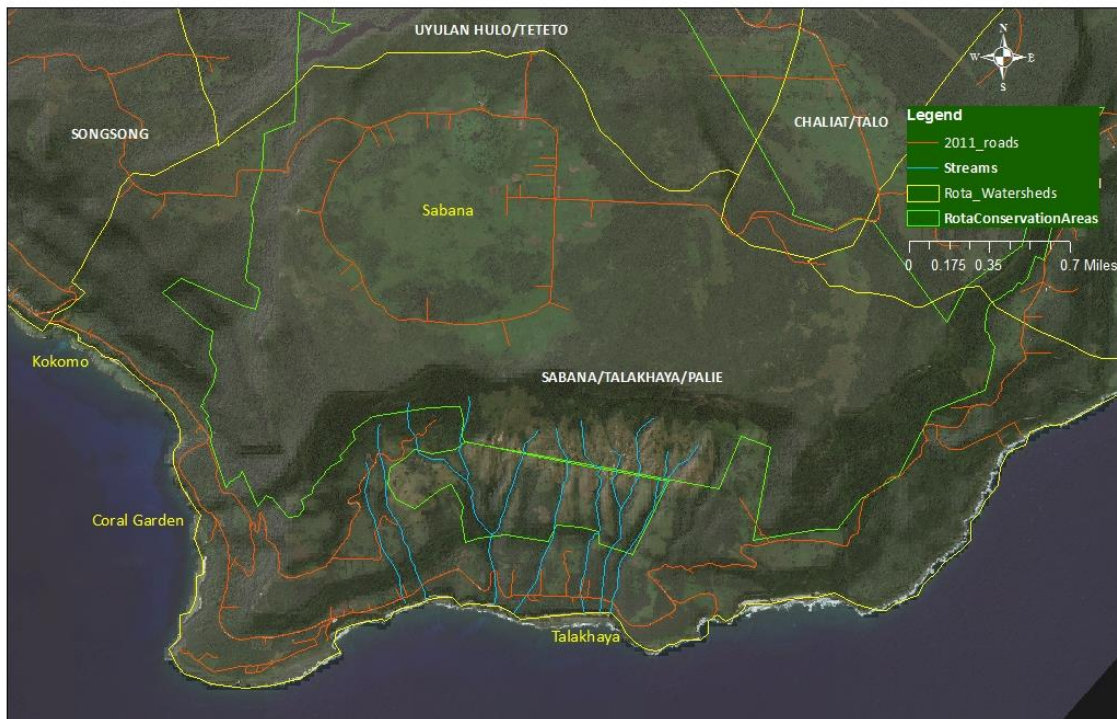
FIGURE C-55. Sabana/Talakhaya/Palie (Segment 2)

The Sabana/Talakhaya/Palie watershed is steeply sloped with barren badlands in Talakhaya's upper watershed as shown in Figure C-55.

This is the result of vast clear cutting for agriculture, which began during the Japanese occupation. Clearings above Rota's primary potable water source, the Water Cave, have continued in recent years for new agricultural plots.

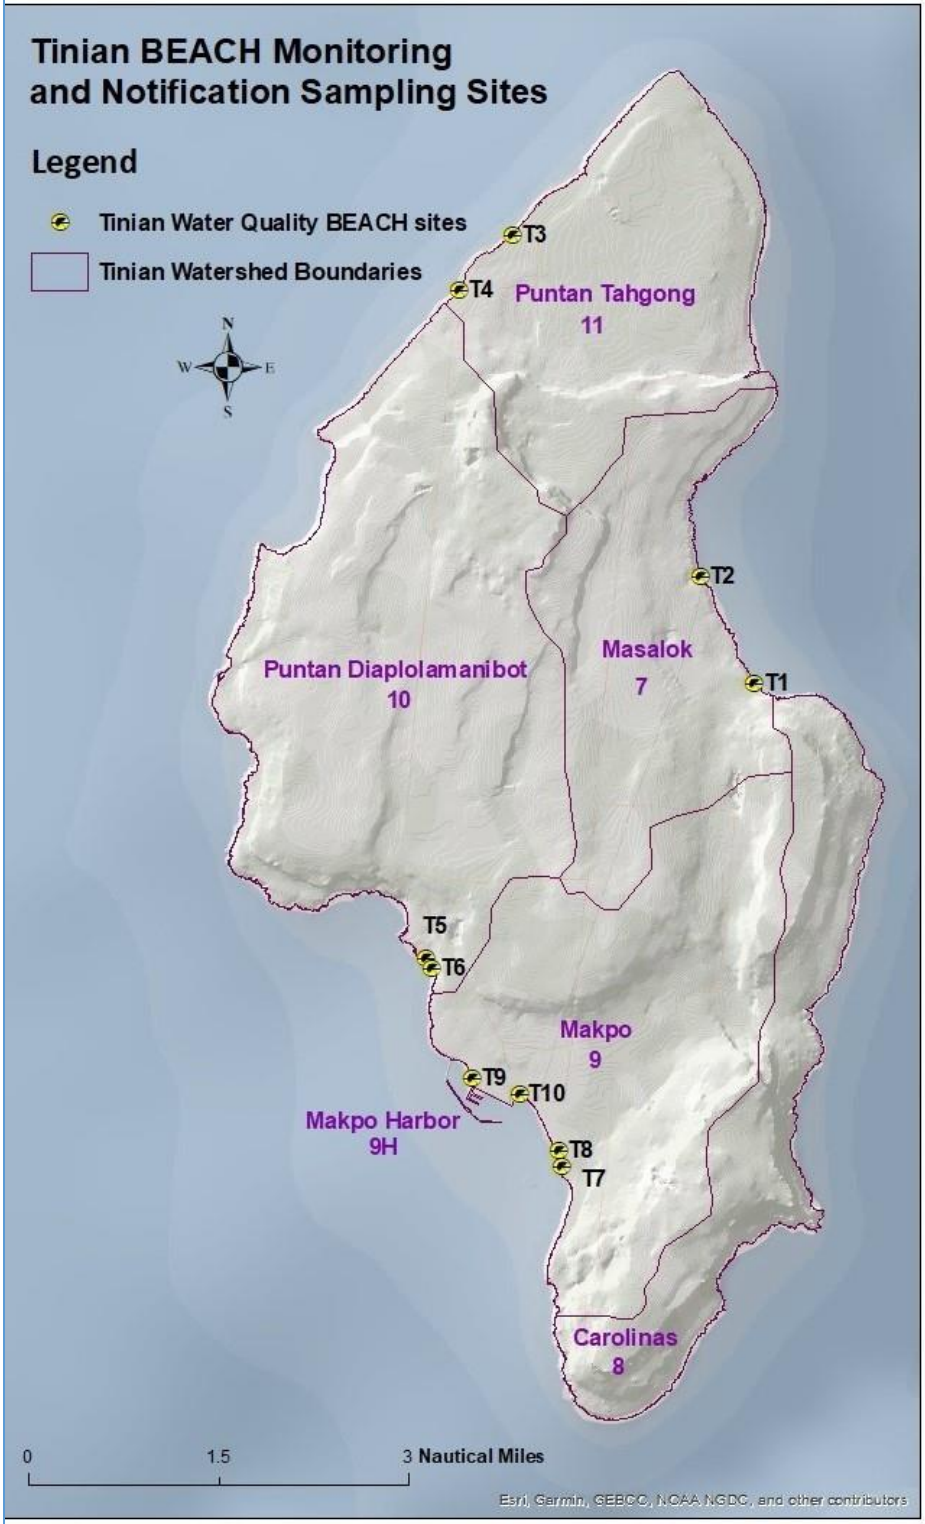
FIGURE C-60. Tinian BEACH Water Quality Sites and Aguigan Biological Monitoring Sites

As was stated for Rota, there are only limited water quality data for Tinian's coastal waters taken from 10 long-term BEACH monitoring sites (Figure C-60., on the following page). A new site at Chiget Beach north of Unai Babui will be added before next reporting cycle. Tinian also has 21 long-term biological monitoring reef sites around Tinian and two around Aguigan. (Figure C-61).

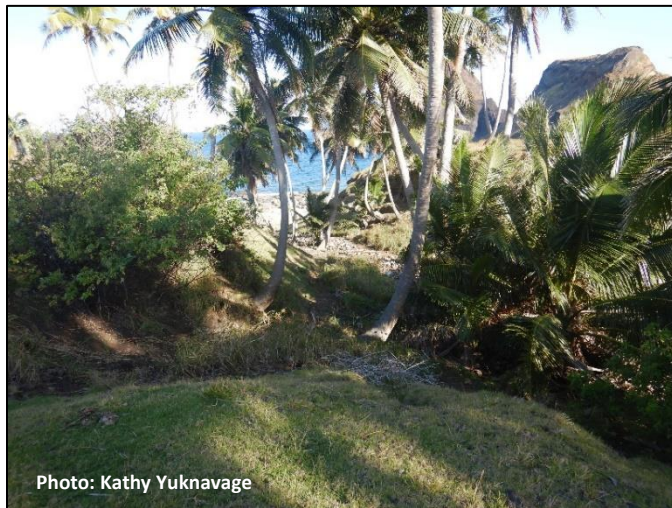
FIGURE C-83. Ravine Leading to Unairididi Beach

Most precipitation on Pagan flows through subterranean transport from land to sea. However, the deep ravines on Mt. Pagan's northern slope may have ephemeral streams that flow over land to the coast (2020. Personal Communication, Capt. Tenorio).
