Commonwealth of the Northern Mariana Islands Integrated 305(b) and 303(d) Water Quality Assessment Report

Division of Environmental Quality
May, 2006

Authors: Frances Castro, Peter Houk, Derek Chambers, and Clarissa Tanaka

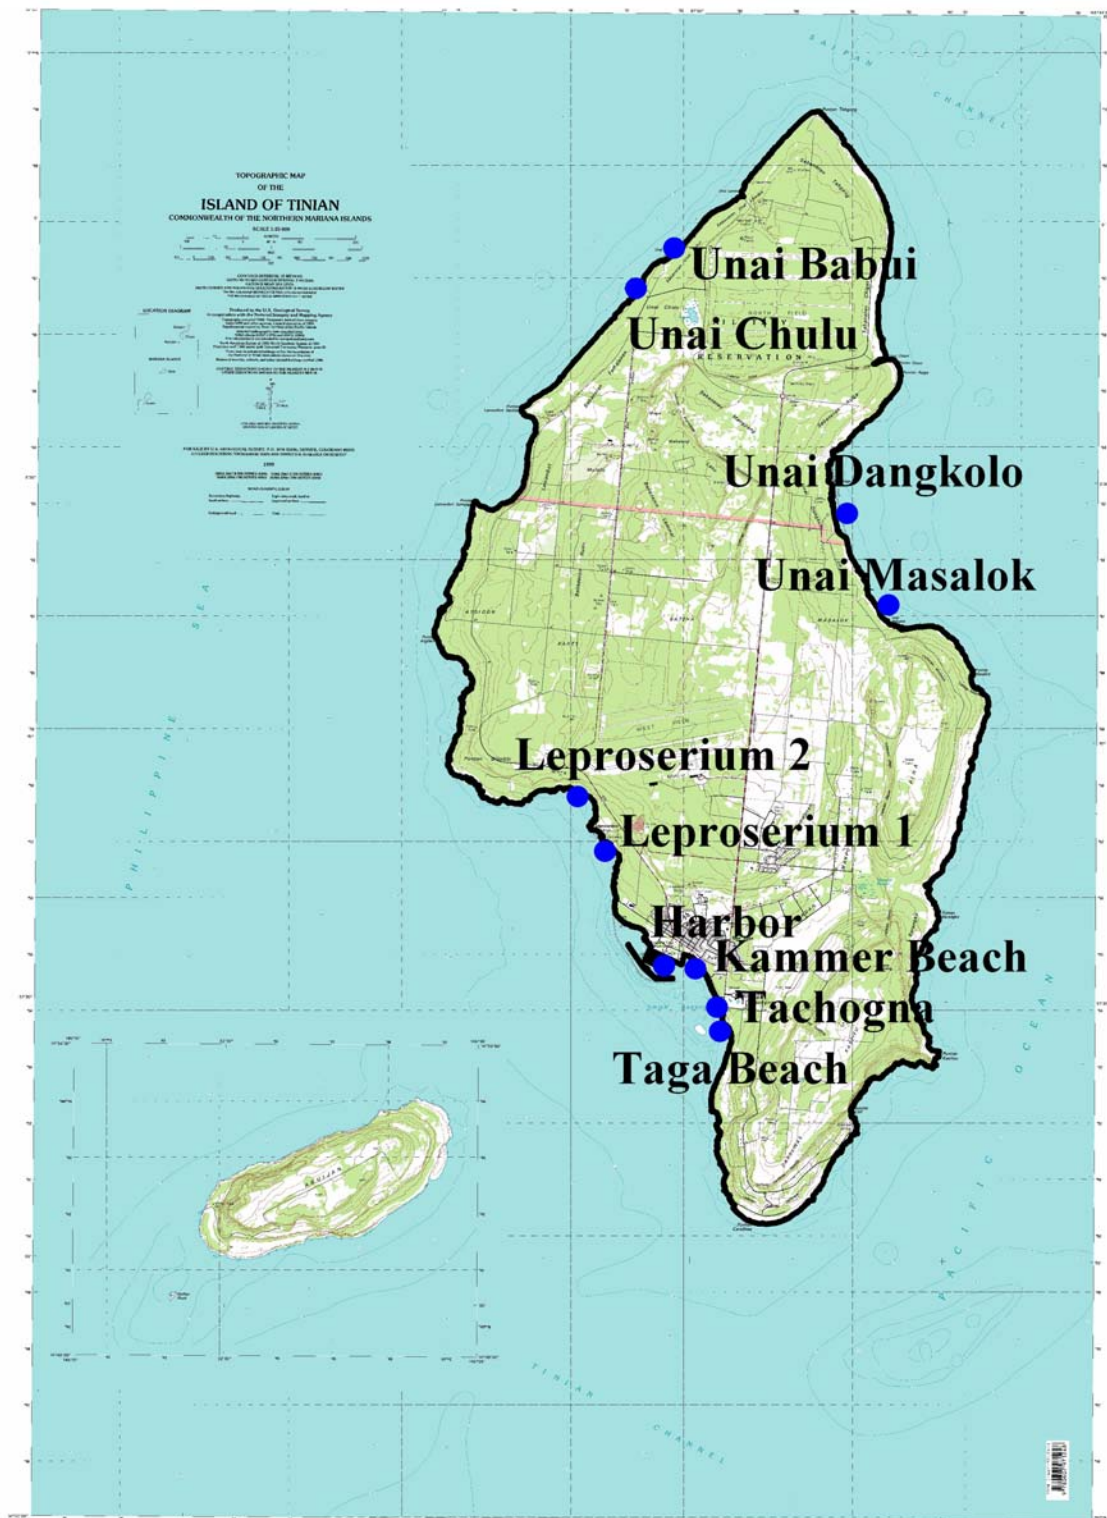
Figure 7. Tinian Island Beach Water Quality Monitoring Locations.

Tinian and Rota monitor eleven and twelve beach areas respectively (Figure 7 and 8, respectively). These sites are frequently used by the community so they are now being monitored at similar intervals described above for Managaha Island.

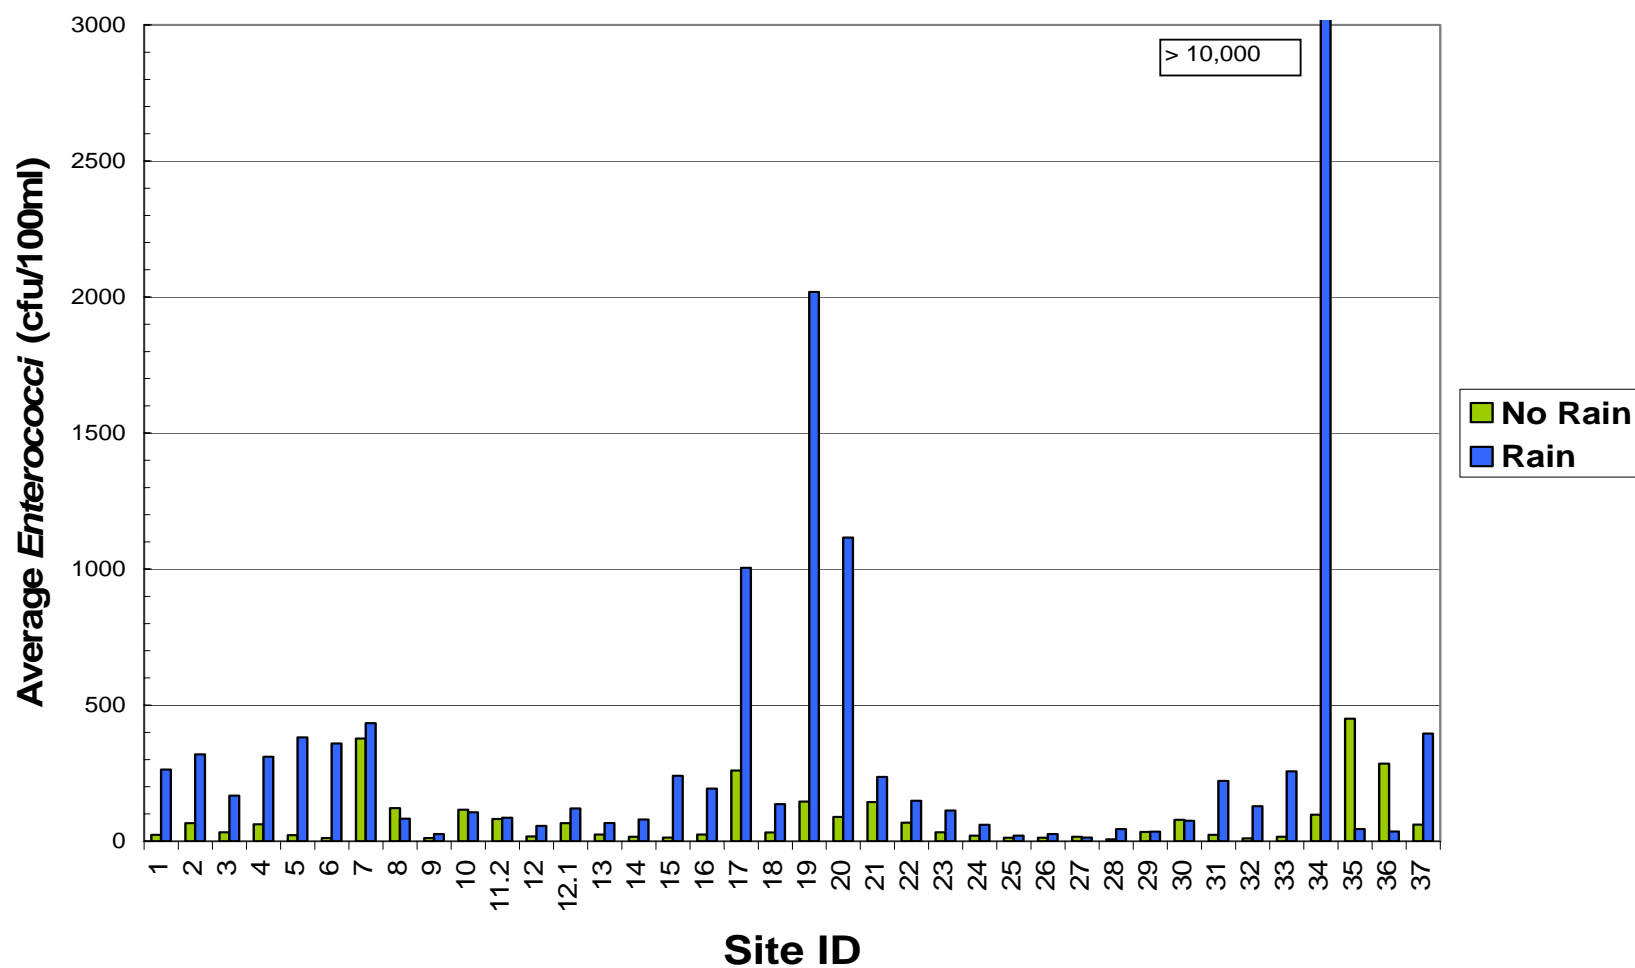
Figure 9. Average *enterococci* bacteria levels at Saipan beach monitoring sites during rain (daily value > .15 inches), and non-rain events for 2004.

eight listed as partially supportive waterbodies (Table 7 - 9). Recreational use classifications were based upon *enterococci* bacteria violations. There was a large enough sample size for Saipan Island to carry out regression analysis between rainfall (independent) and *enterococci* bacteria counts (dependent) (Table 7). Rainfall explained a significant amount ($p < .05$, regression analysis) of the variance in bacteria levels in Saipan waterbodies (Table 7) (Figure 9 and 10). Observations have shown that storm events quickly inundate many of the sewage lift stations around Saipan, and the overflow enters the marine environment through drainages. Additionally, storm events carry untreated urban and rural runoff quickly to the ocean. This leads to predictable, elevated bacteria levels at many beach locations during storm events. In Rota, impaired waterbodies were associated with marinas and boat launching areas, other waters were found to be in excellent quality. It is not clear why an increase in bacteria violations was noted for Tinian waters in 2005 (6 partially supportive waterbodies) as compared with 2004 (all waters were fully supportive). Regressions with rainfall data were all not significant for Tinian monitoring sites, and much stormwater is discharges through the porous limestone rock as groundwater.
