Commonwealth of the Northern Mariana Islands Integrated 305(b) and 303(d) Water Quality Assessment Report

Division of Environmental Quality Revised: October, 2008

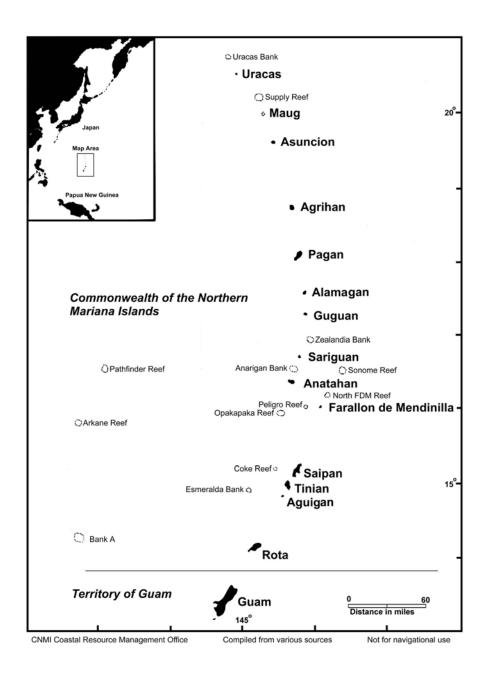
Figure 1. The Mariana Islands.

The Commonwealth of the Northern Mariana Islands (CNMI) consists of two geologically distinct island chains located at 145° E, between $14^{\circ} - 21^{\circ}$ N (Figure 1). The Southern Mariana Islands are between 5 and 20 million years old and consist of raised, limestone reef bedrock resultant from high sea level stands prior to the Holocene (~6,000 before present) (Karig, 1975, Mrozowski and Hayes, 1980). The Northern Islands lie to the northwest, residing on the still active Mariana Ridge. This report contains information from the southern islands of Saipan, Tinian, Aguijan, and Rota, where the vast majority of the population lives (Table 1). Saipan is the capital of CNMI, and the largest and most inhabited of the islands. Threats to water quality are greatest in Saipan, where DEQ operations are based, resulting in more resources being dedicated to understanding these impaired waters.

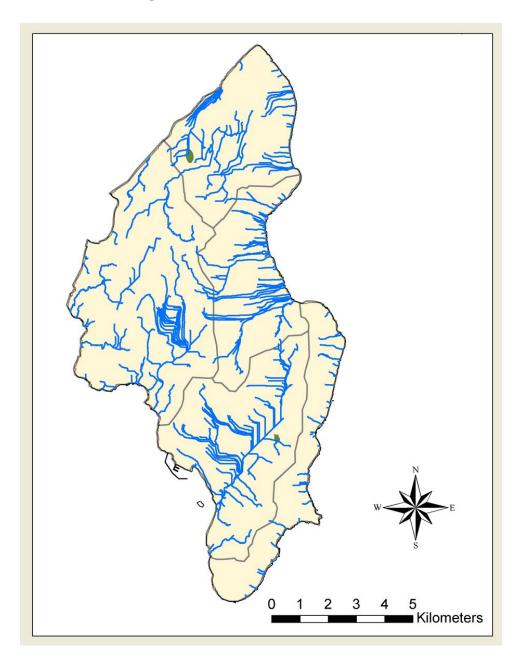
Figure 2. Class 1 waters of Saipan: watersheds (black, outlined), intermittent streams (blue), wetlands (green), and coral reefs are shown in dashed black lines.

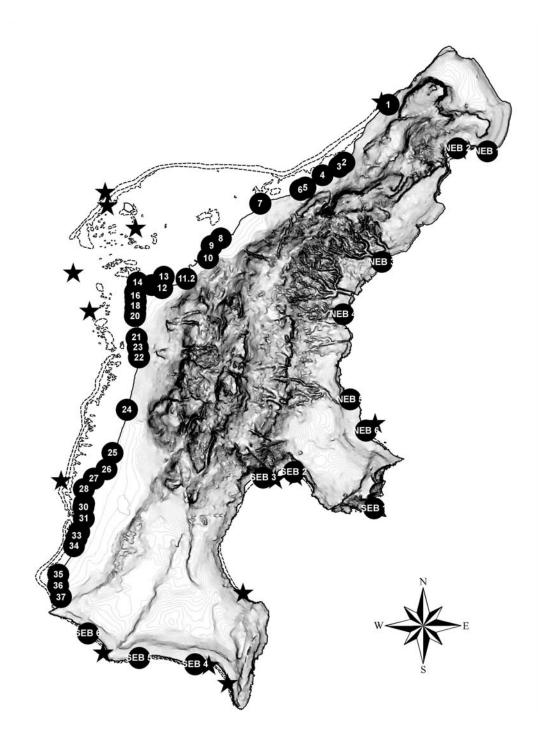
Figure 5. Saipan Island beach water quality monitoring locations, biological criteria monitoring stations are indicated by the stars.

On a weekly basis, DEQ monitors 39 fixed stations along Saipan's most frequented west coast beaches for microbiological and chemical parameters (Figure 5). Six beaches on the northeast coast and six beaches on the southeast coast are monitored on a 8-week rotational basis, and monthly during the non 8-week cycle, because the quality of the water is consistently good and/or a smaller population uses these waters. Eleven sites around Managaha Island, a small (~1.5 km coastline) island located within the Saipan Lagoon, are also monitored on a 8-week rotational basis, and monthly during the non 8-week cycle (Figure 6). On Tinian and Rota DEQ monitors eleven and twelve locations, respectively (Figures 7 and 8), that are frequently used by the community.

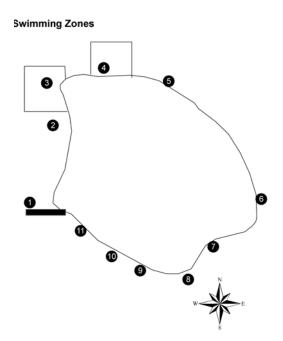
Figure 6. Managaha Island beach water quality monitoring locations, biological criteria monitoring stations are indicated by the stars.

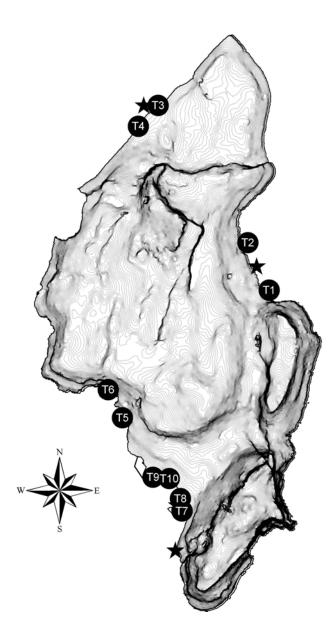
Figure 7. Tinian Island beach water quality monitoring locations, biological criteria monitoring stations are indicated by the stars.

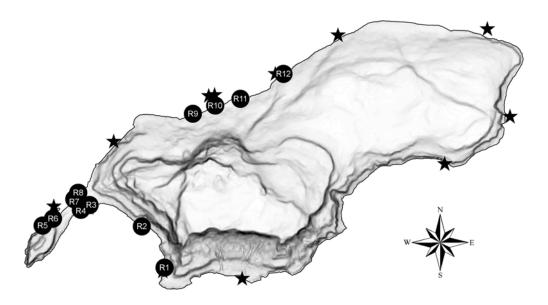
Figure 8. Rota Island beach water quality monitoring locations, biological criteria monitoring stations are indicated by the stars.

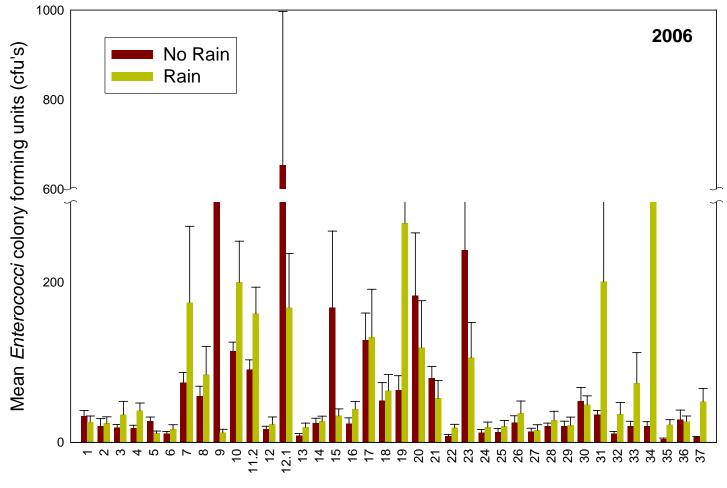
Figure 9. Average *enterococci* bacteria levels at Saipan west beach monitoring sites during rain (daily value > 0.10 inches), and non-rain events for 2006.

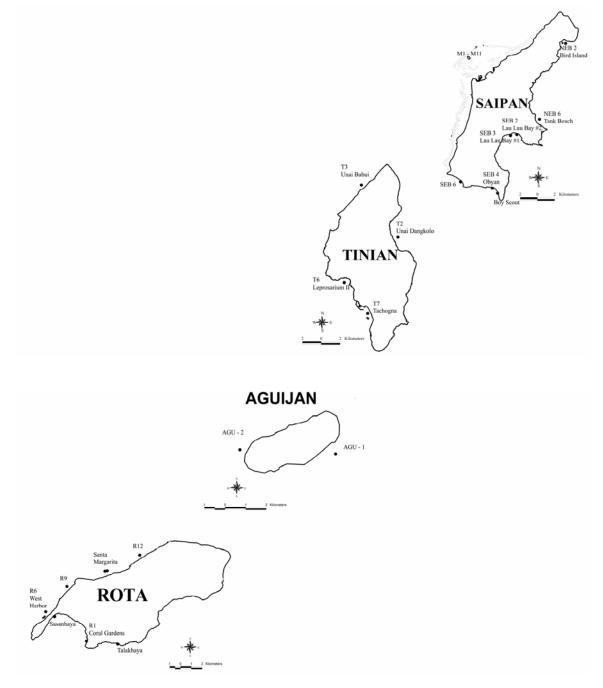
Figure 12. A map of coral reef biocriteria monitoring locations used in the present assessment.

Twenty one coral reef surveys were conducted for waterbody evaluation (Figure 12). Of the twenty one locations surveyed, 5 were non-supportive, 11 were partially supportive, and 5 were fully supportive for aquatic life use (Table 10). Compared with the 2006 rankings there was an overall decline in the number of fully supportive sites from 10 to 5, as most sites are now classified as partially supportive. This is attributed to our generation of trend data that has enabled us to more accurately estimate the direction (positive or negative) biological assemblages are heading. Not supportive rankings were suspected to be a consequence of sedimentation, polluted groundwater discharge, and the proximity to boat marinas. Partially supportive sites are all associated with large volume watersheds with varying levels of suspect pollution. Further studies are currently underway to formulate a predictive knowledge regarding the expected benthos abundances given a set of watershed statistics. DEQ aims to continue their monitoring program and further trend data collection for our coral reefs. This will help to evaluate the effectiveness of management strategies and action, and allow for a priority ranking of remaining, problematic watersheds. Figure 11. A map showing all *Halodule* seagrass habitats throughout the Saipan lagoon color coded as follows: red = non-supportive, yellow = partially supportive, green = fully supportive.
