2022
Commonwealth of the Northern Mariana Islands
305(b) and 303(d)
Water Quality Assessment Integrated Report

Bureau of Environmental and Coastal Quality
SEPTEMBER 2022

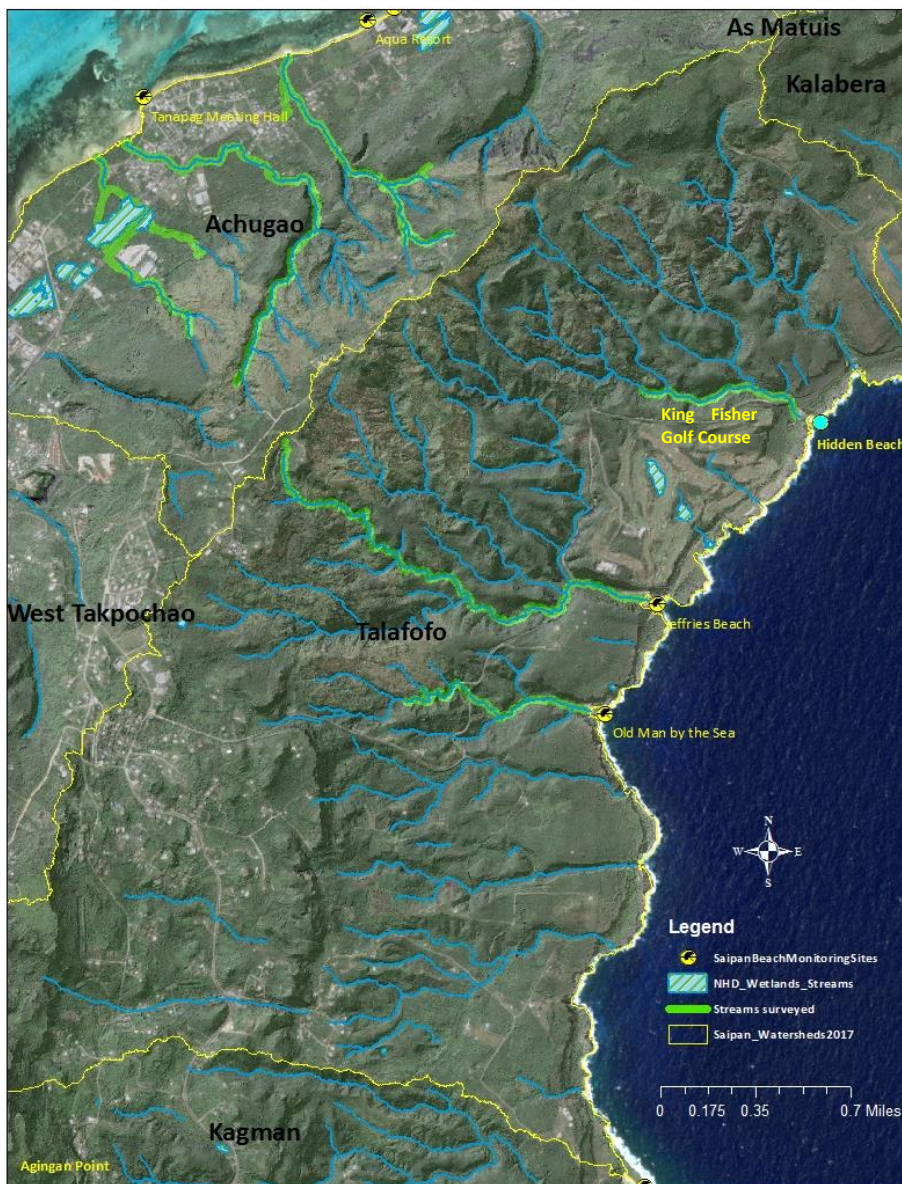
FIGURE C-10. Talofofo Watershed (Segment 13)

Talofofo Watershed’s long-term BEACH monitoring sites are located in the waters surrounding three remote beaches: Hidden, Jeffrey’s, and Old Man by the Sea, as shown in Figure C-10.

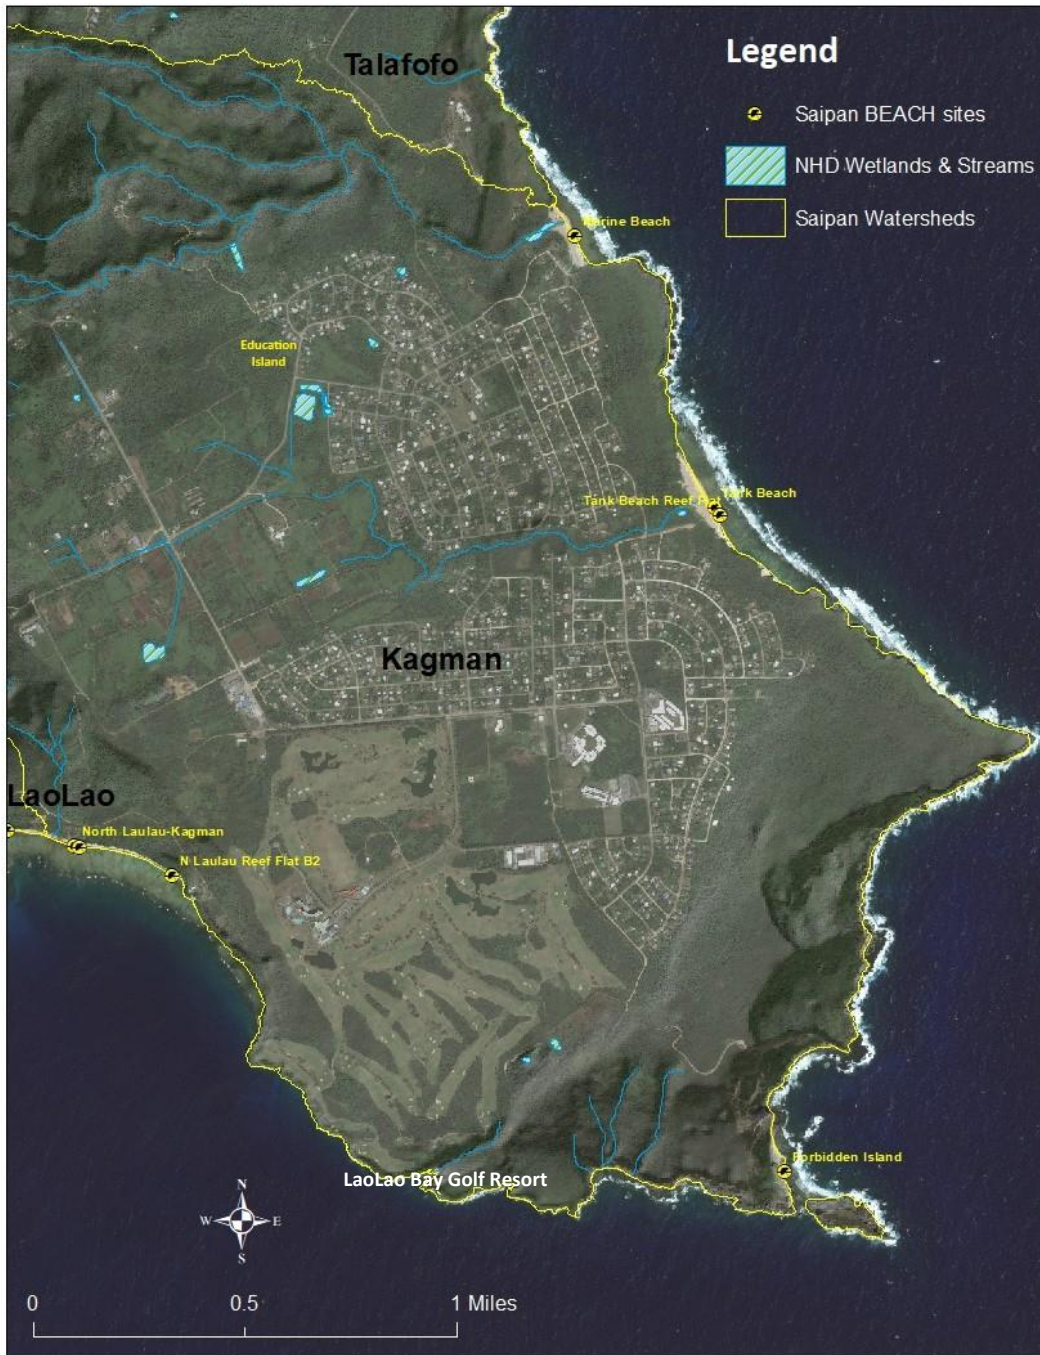
FIGURE C-11. Kagman Watershed (Segment 14)

The Kagman Watershed borders LaoLao Bay and contains the LaoLao Bay Golf Resort, shown in Figure C-11.

It has four long-term BEACH monitoring sites located in the waters surrounding Marine, and Tank, and Forbidden Island, and North LaoLao beaches. In addition, there are also three LaoLao ARRA water quality sites, and two biological monitoring reef flat sites used to assess Kagman's coastal waters. These sites are adjacent to LaoLao's northern beach, one of Saipan's most popular dive sites.

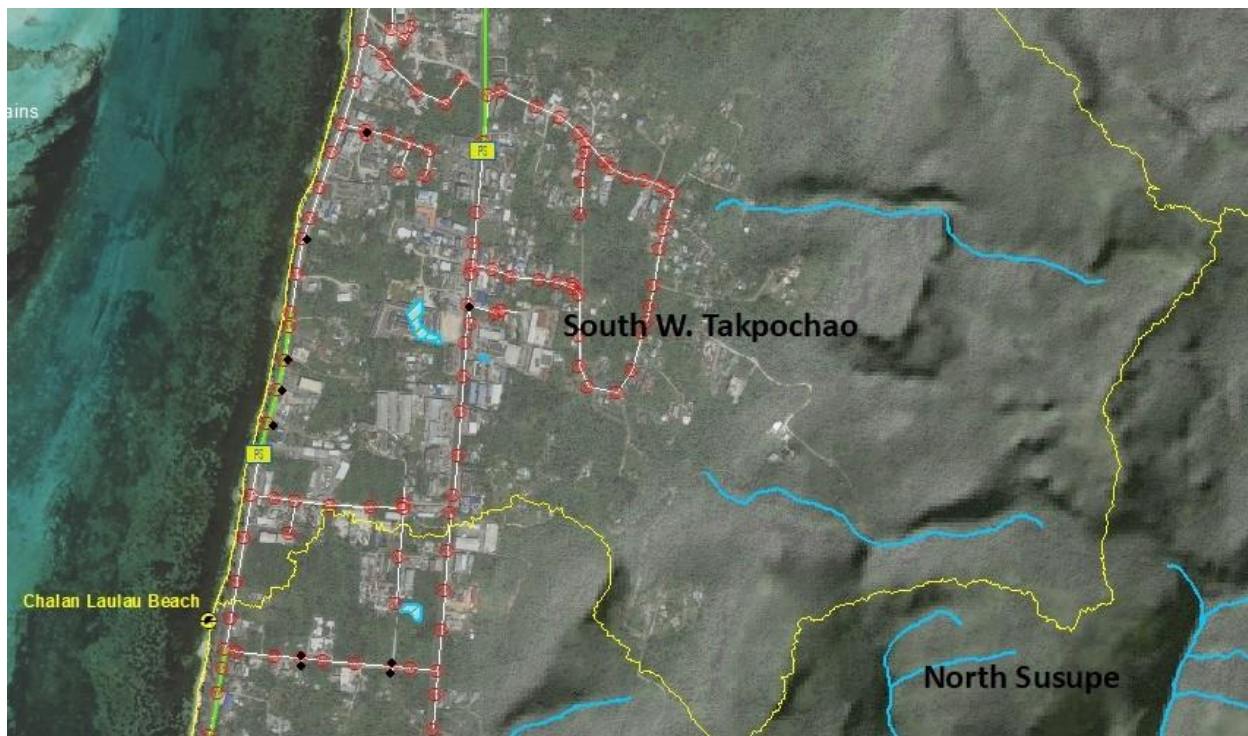
FIGURE C-31. South W. Takpochau Streams (Segment 19STRC)

There are two ephemeral streams in the South West Takpochau watershed as seen in the latest NHD, and Wetlands and Stream GIS data layers. The streams' headwaters start at the ridge separating North Susupe from the South West Takpochau watershed. The streams flow on the surface from the steep upper watershed in the west, then subterranean through the lower watershed that discharges through groundwater seeps into Saipan Lagoon.

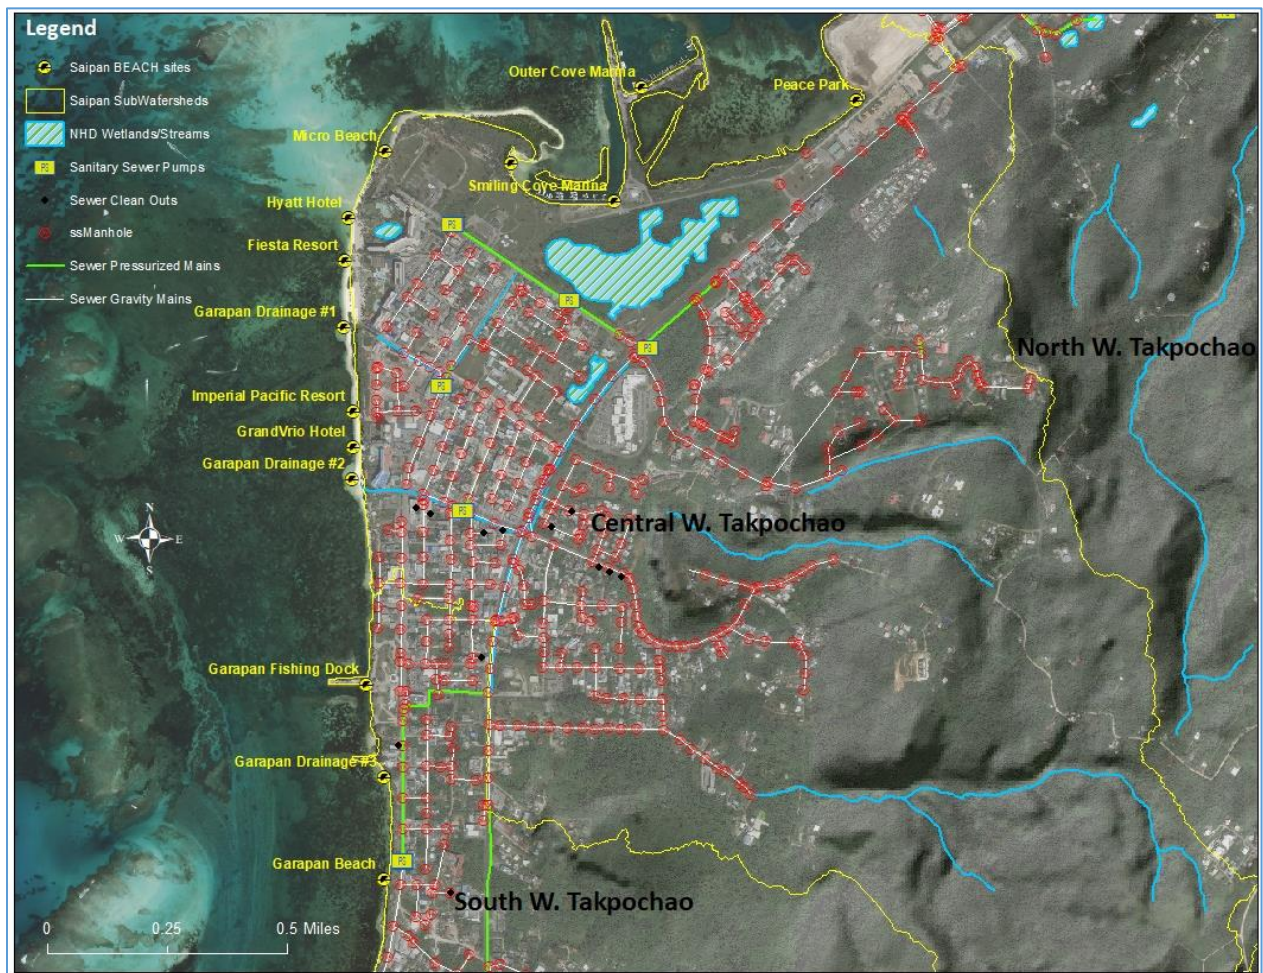
FIGURE C-32. Central W. Takpochau Watershed (Segment 19B)

Saipan’s Beach Path winds its way along the Central West Takpochau’s shoreline into Saipan’s “industrial area”. The coastal waters surrounding the industrial area have been designated as Class A waters. As was discussed previously in Section B.1.4.2, these coastal waters contain Smiling Cove and Outer Cove Marinas.

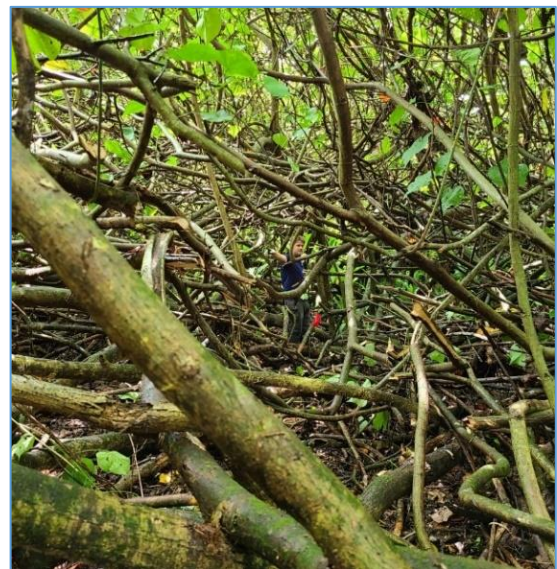
Another site located north of Middle Rd. and west of Isa Drive is a beautiful mature lacustrine hibiscus forested wetland with large bird nest ferns. The wetland provides habitat for several endangered Nightingale Reed Warblers (Figure C-37).

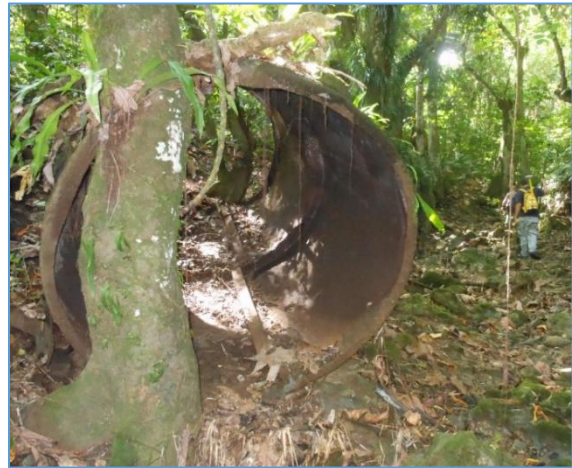
FIGURE C-40. Cistern in Dogas Streambed

SVAP assessments were completed within and around South Achugao’s As Agatan and Saddok Dogas stream systems. Several large cisterns from the Japanese occupation, and metal drums, WWII UXO, planes and other military equipment can be found in the mid Saddok Dogas stream system.

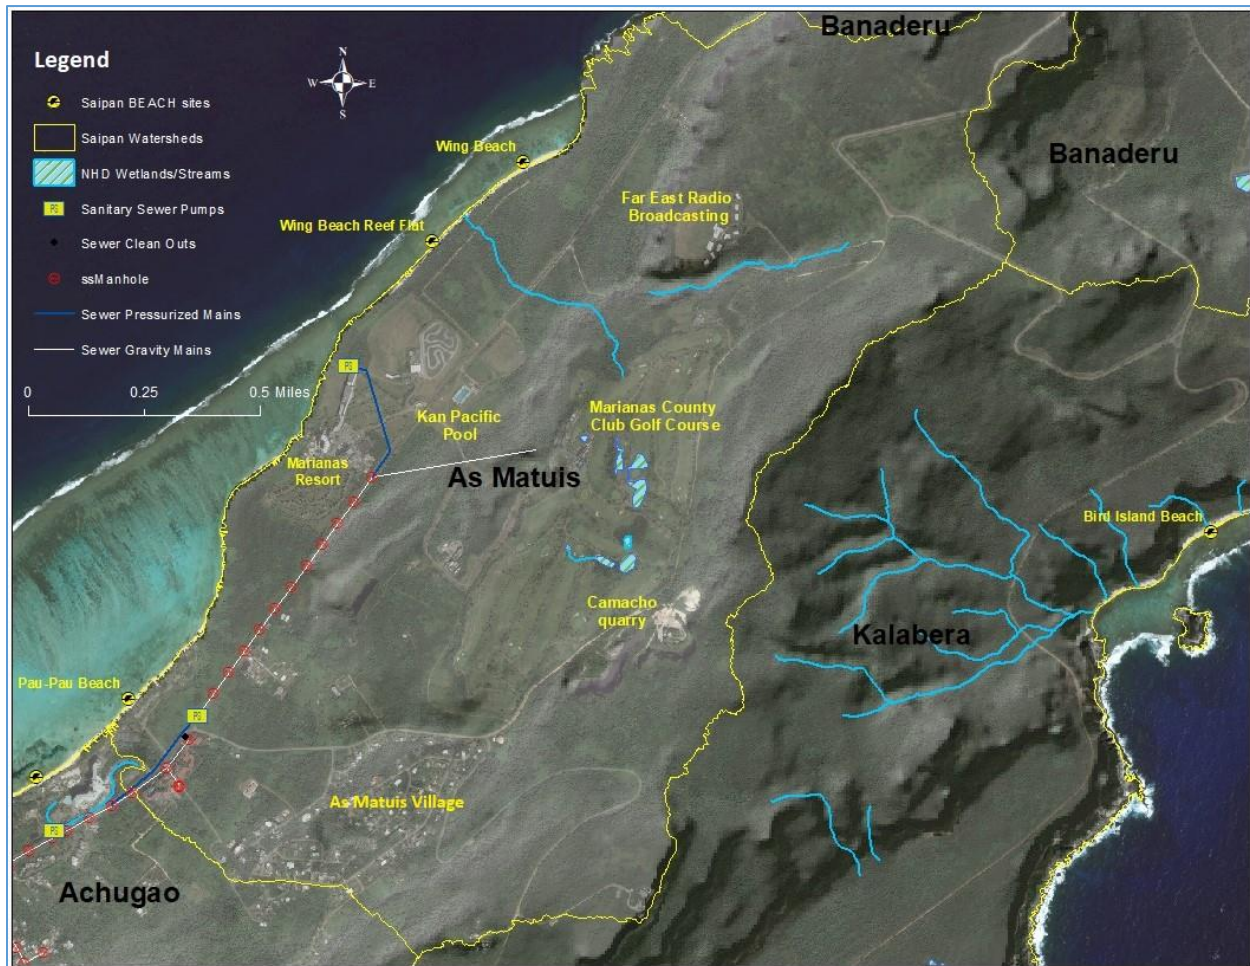
FIGURE C-47. As Matuis Watershed (Segment 21)

relies, on IWDS for wastewater collection and treatment. The SR-2 lift station upgrade near PauPau Beach was completed this reporting cycle.

As Matuis has two (2) long-term BEACH monitoring sites at Pau Pau and Wing Beaches, and has three additional biological ALUS monitoring sites on the Wing Beach forereef, reef flat, and Pau Pau seagrass assemblage. There was no significant improvement to the Wing Beach forereef benthic substrate, which remains ranked as “Poor”. Wing Beach’s reef flat’s ALUS was assessed for the first time this reporting cycle. Both the reef flat’s benthic habitat and the Pau Pau seagrass assemblages were ranked as “Fair”. However, there has been little data collected on these two biological sites. Therefore, As Matuis’ cumulative five year ALUS ranking for its coastal waters remains ranked as “Poor” until more data shows improved habitat.

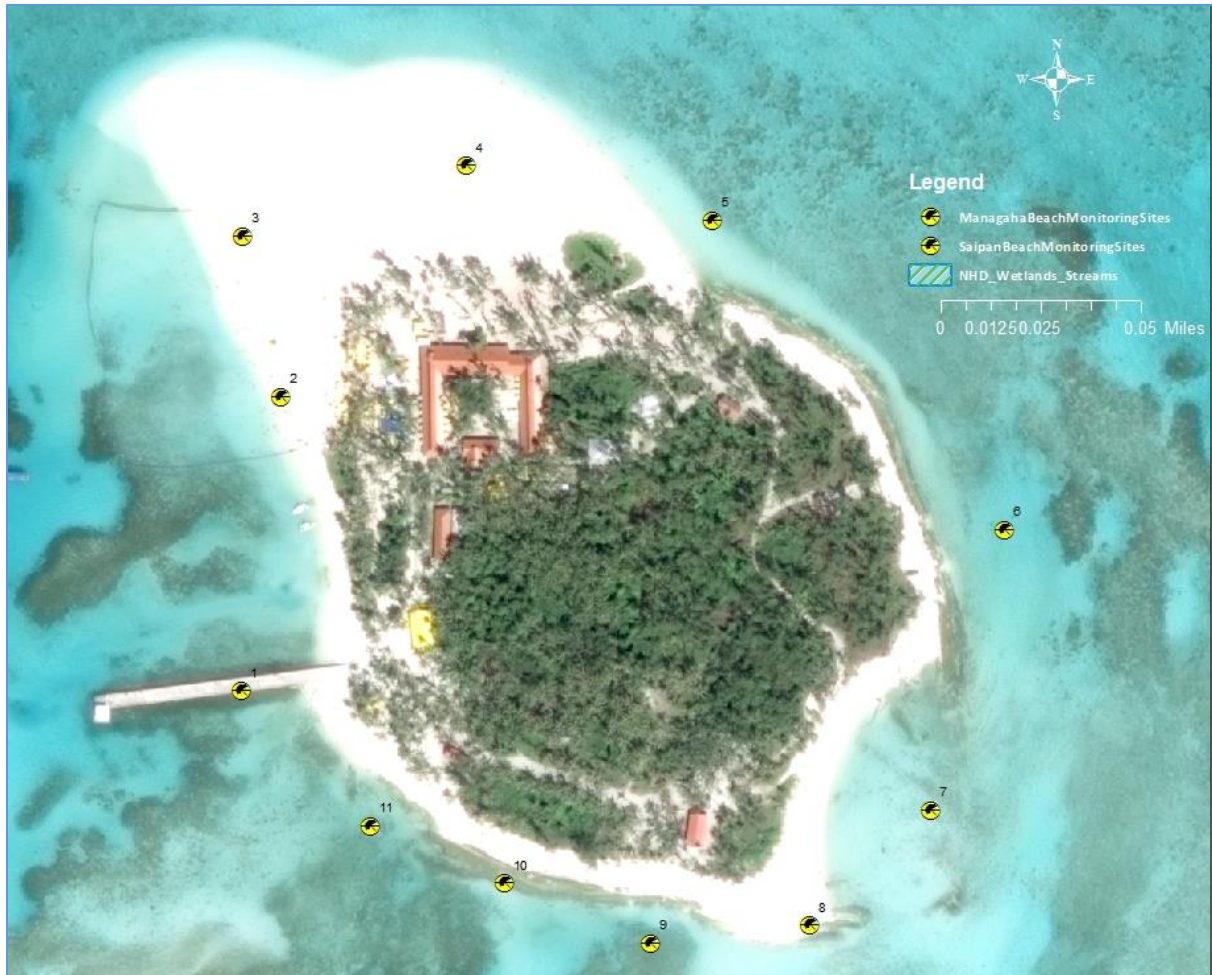
FIGURE C-51. Mañagaha (Segment 23)

There are 11 long-term BEACH monitoring sites surrounding Mañagaha’s shoreline and pier (Figure C-50., on the previous page).

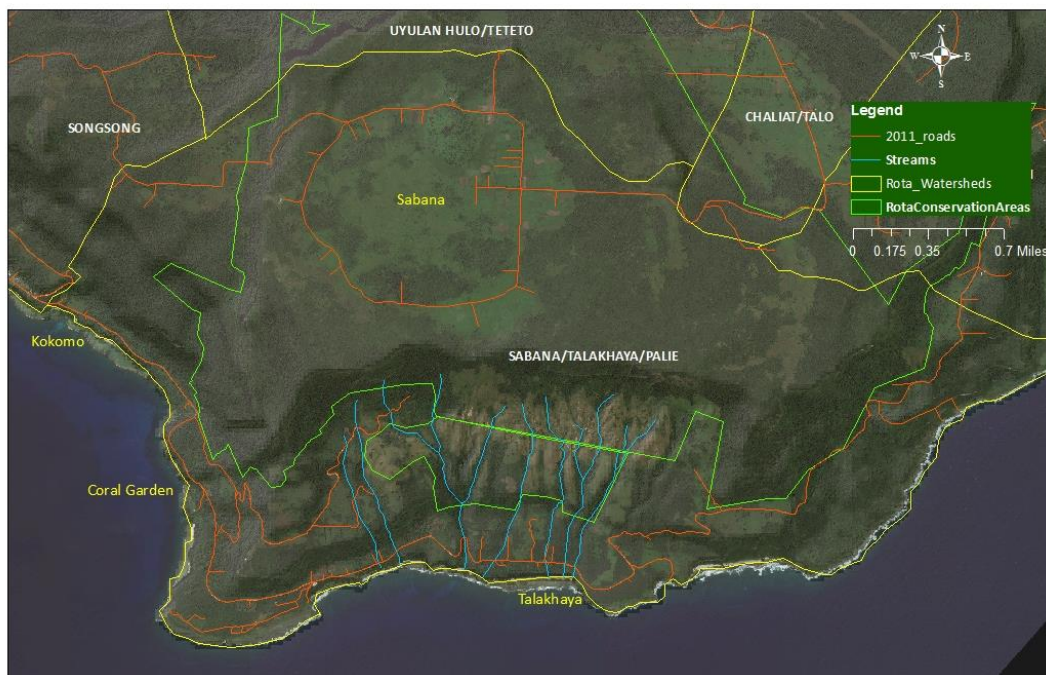
FIGURE C-55. Sabana/Talakhaya/Palie (Segment 2)

The Sabana/Talakhaya/Palie watershed is steeply sloped with barren badlands in Talakhaya's upper watershed as shown in Figure C-55.

This is the result of vast clear cutting for agriculture, which began during the Japanese occupation. Clearings above Rota's primary potable water source, the Water Cave, have continued in recent years for new agricultural plots.

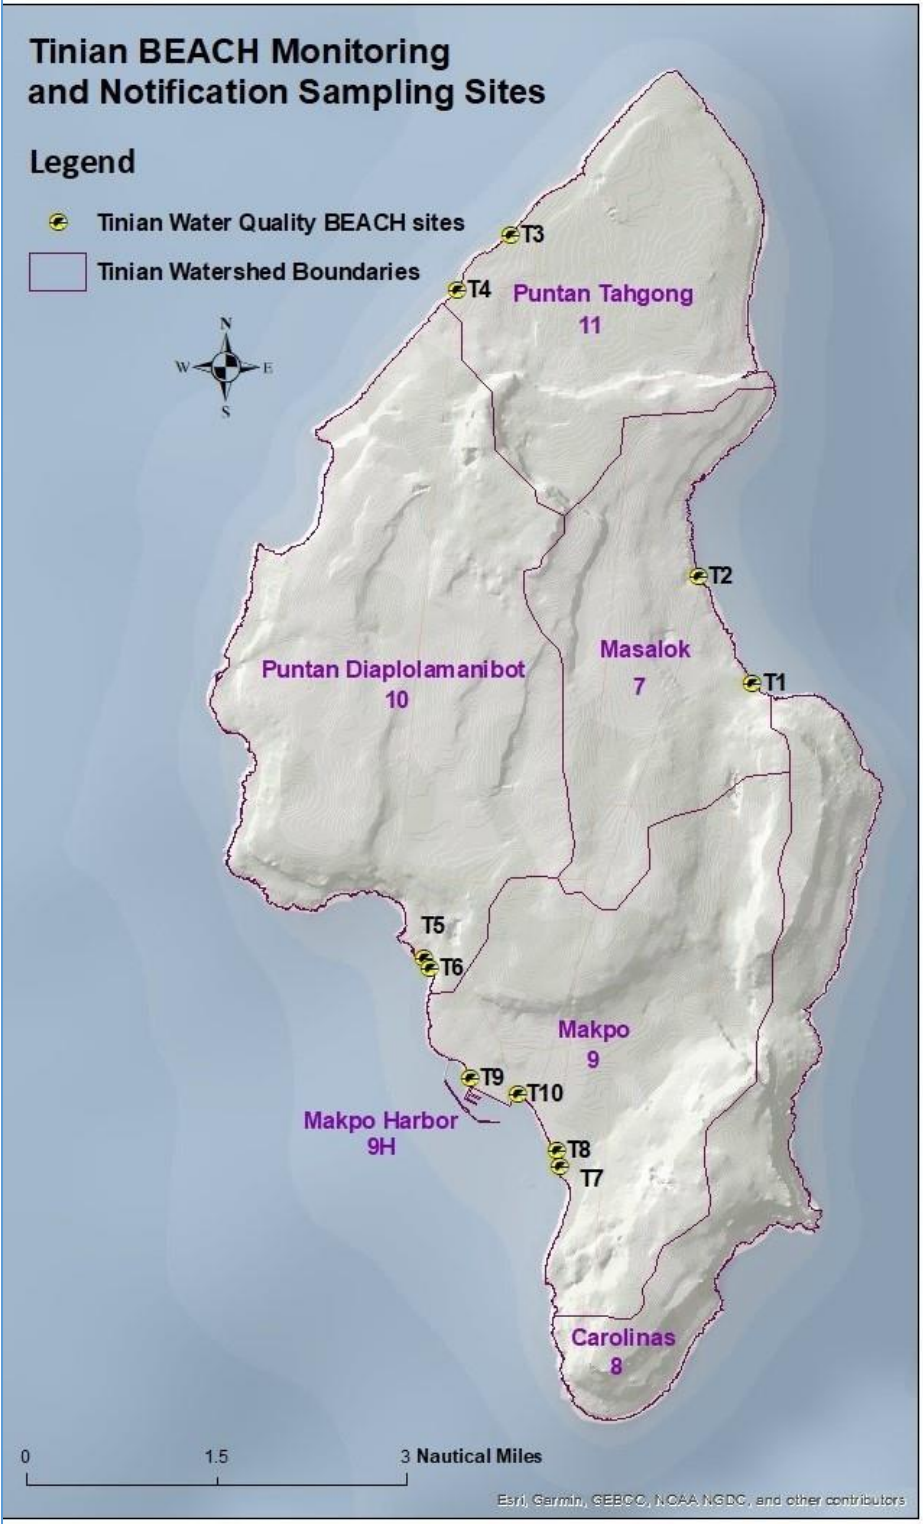
FIGURE C-60. Tinian BEACH Water Quality Sites and Aguigan Biological Monitoring Sites

As was stated for Rota, there are only limited water quality data for Tinian's coastal waters taken from 10 long-term BEACH monitoring sites (Figure C-60). A new site at Chiget Beach north of Unai Babui will be added before next reporting cycle. Tinian also has 21 long-term biological monitoring reef sites around Tinian and two around Aguigan. (Figure C-61).

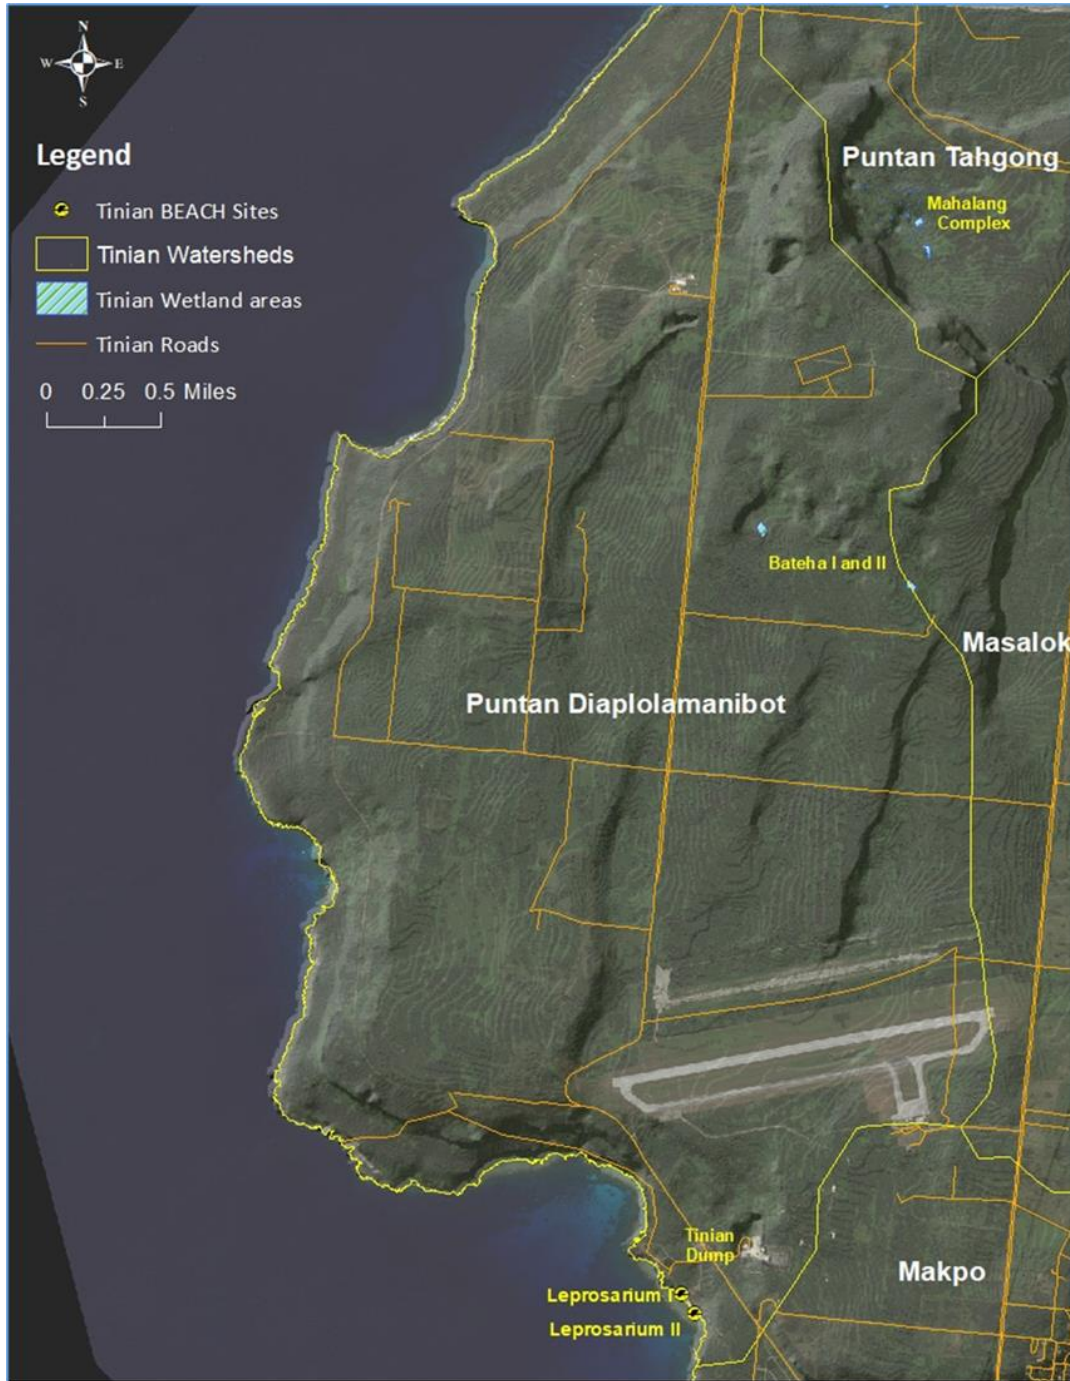
FIGURE C-68. Puntan/Diapolamanibot (Segment 10)

These calm shallow beach areas are protected by a shallow fringing reef. Cuts were made into the reef for supply boats to access the beach and to bring provisions to the colony. The cuts are still visible today, but are no longer used for boat landing. However, the beach sites may be easily reached by using a secondary coral road.

monitoring sites at Leprosarium I and II beaches. These beaches were used during the Spanish occupation to provide a distant location to quarantine a Leprosy colony (see Figure C-68).

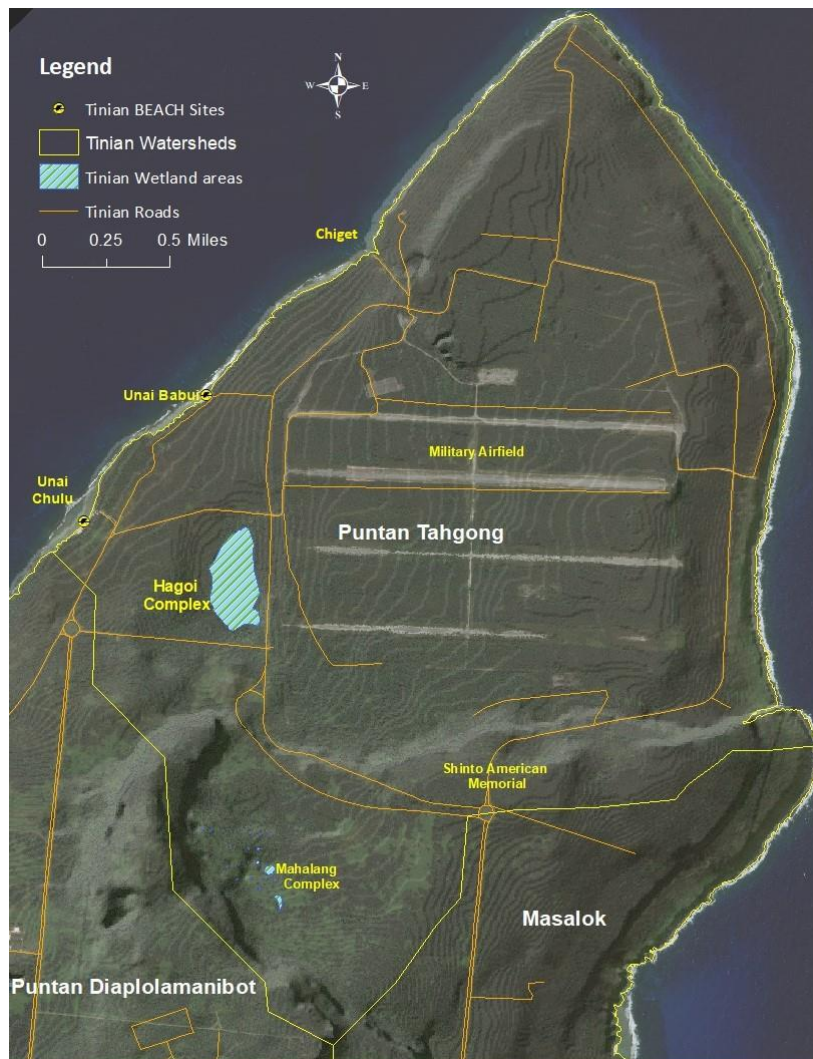
FIGURE C-70. Puntan/Tahgong (Segment 11)

It is contained in the US Military leased land area, and contains two long-term BEACH monitoring sites, including Unai Babui (“Pig Beach”) and Unai Chulu beaches (see Figure C-70 above).

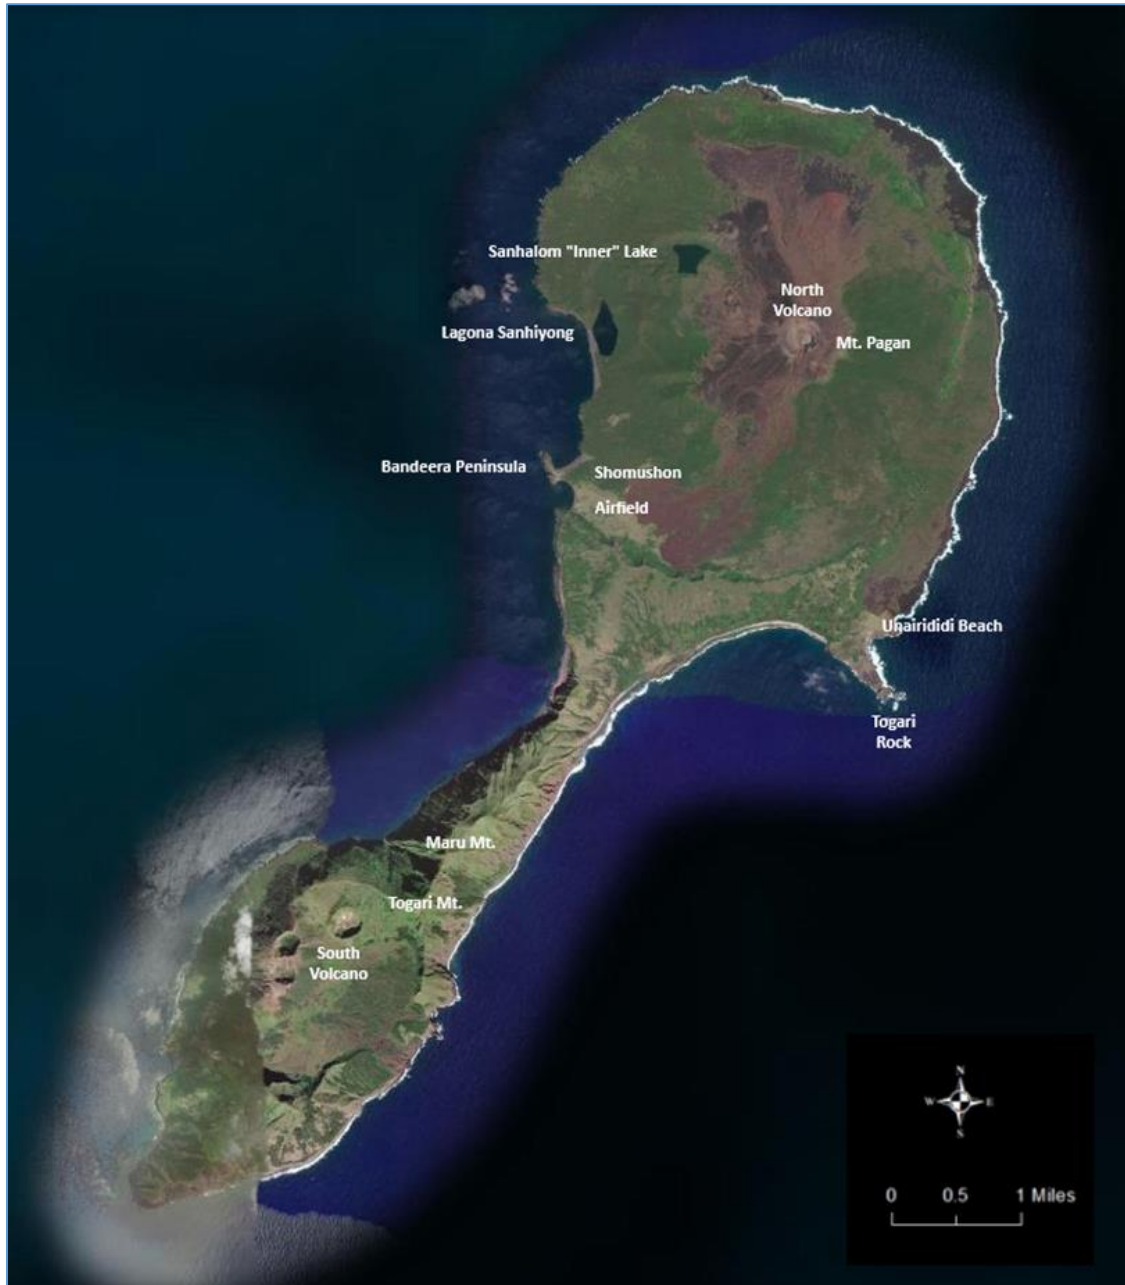
FIGURE C-80. Pagan – Earthstar Geographics Powered by ESRI imagery (Segment 29)

Mt. Pagan, at 1,870 feet (Smithsonian VDP), lies within a caldera in the north. This volcano is separated by a narrow isthmus (a strip of land surrounded by marine waters on either side) from three volcanoes in a caldera in the south. The isthmus is also “composed of another volcanic center (the highest point is Togari Mountain...) at 579 m above sea level.

According to the Smithsonian GVP, Pagan is one of the largest and most active of the Northern volcanic Islands, with 28.2 miles of coastline. Trusdell stated that it is the second most active after FDP and is “made up of a string of volcanoes originating from three volcanic centers..., distinguishing the island from the rest of the Mariana Islands.”, (2009. Gillespie). See Figure C-80., on the following page.
